## Flood and Waste Management Act 2010

### Section 19 Flood Investigation Report for Storm Water Flooding at Meadow Street and Railway Street, Llanhilleth

Report Date: June 2021

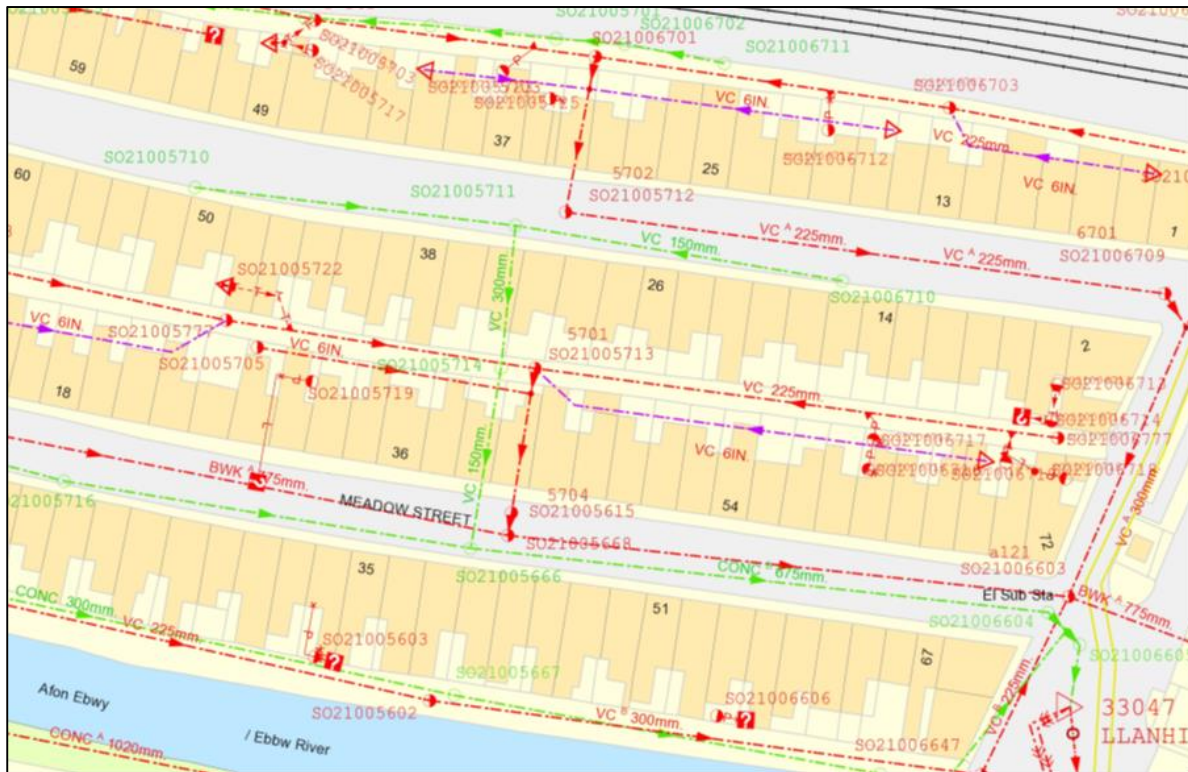
The investigation found that two 150mm diameter storm water pipes run along Railway Street, from easterly and westerly directions, meeting at an inspection chamber at a central point in the street. At this inspection chamber, the size and direction of the outlet pipe changes so that water flows in a 300mm diameter pipe in a southerly direction, beneath a Railway Street property, to an inspection chamber in the rear lane between Railway St. and Meadow St.

At this inspection chamber, observations show that a 150mm diameter pipe has been inserted inside a 300mm diameter pipe throughout its length between the inspection chambers at the rear lane and Meadow Street. This section runs underneath a property in Meadow Street. This reduction in pipe diameter means that there is only a 25% capacity of the original 300mm inlet pipe through this section. This may have led to a build-up of storm water in the smaller pipe causing a discharge from the upstream chamber in Railway Street.

From the chamber in Meadow St. The 150 mm diameter pipe then connects into a chamber, which carries a 675mm diameter storm water culvert that flows underneath Meadow Street in an easterly direction before eventually discharging into the river.

Figure 4: Plan showing the drainage infrastructure of Meadow Street and Railway Street (DCWW, 2020)

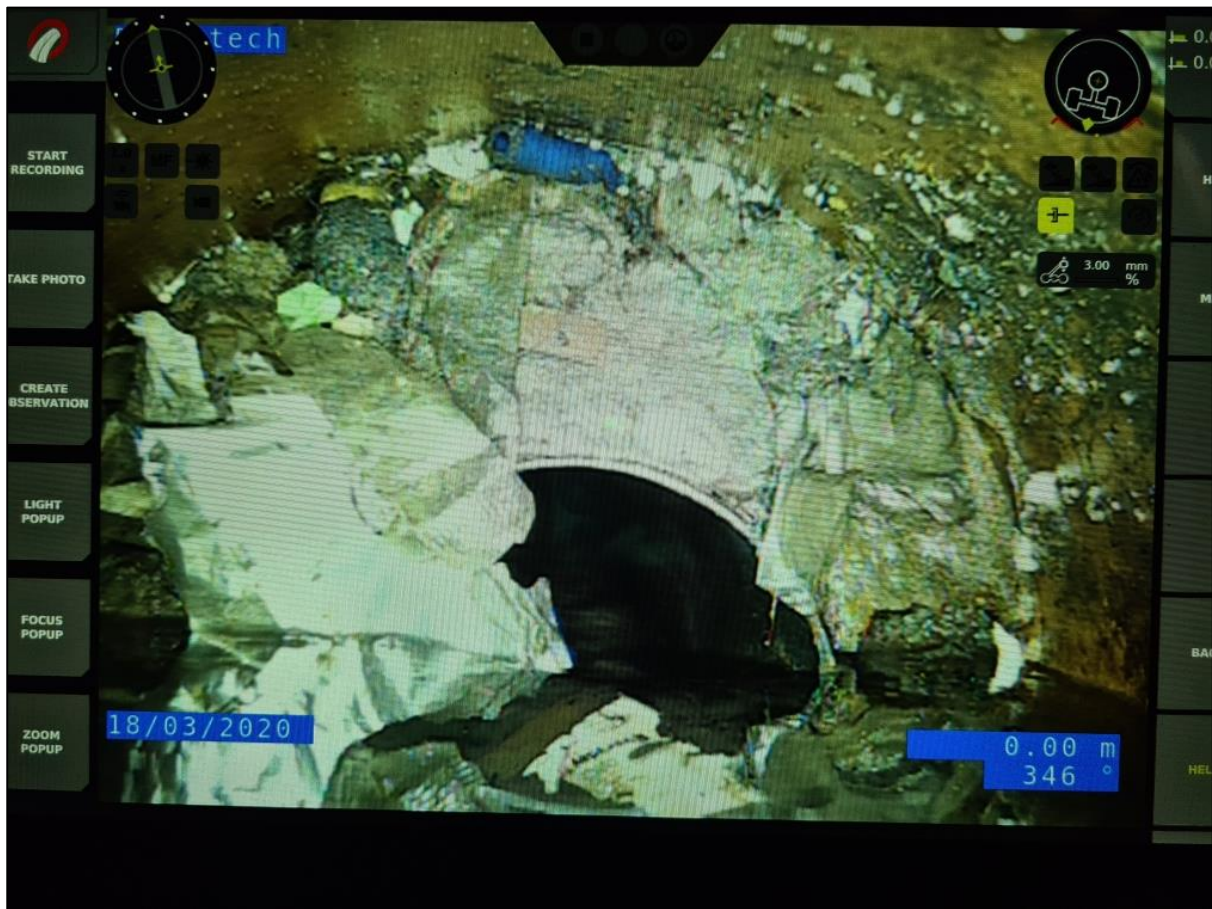
In addition to the reduced capacity along a section of drainage network, a CCTV survey undertaken in March 2020 showed a large amount of debris on an outlet pipe within this drainage infrastructure. It is probable that the build-up of debris in the pipe could have caused a reduction in flow capacity and lead to blockages.

Figure 5 below shows CCTV survey footage of the 150mm pipe inserted into the 300mm pipe between Meadow Street and the rear lane.

Figure 5 CCTV Survey footage of the outlet pipe covered with debris

A CCTV survey was carried out in March 2020 to inspect the drainage system beneath Meadow Street and Railway Street.

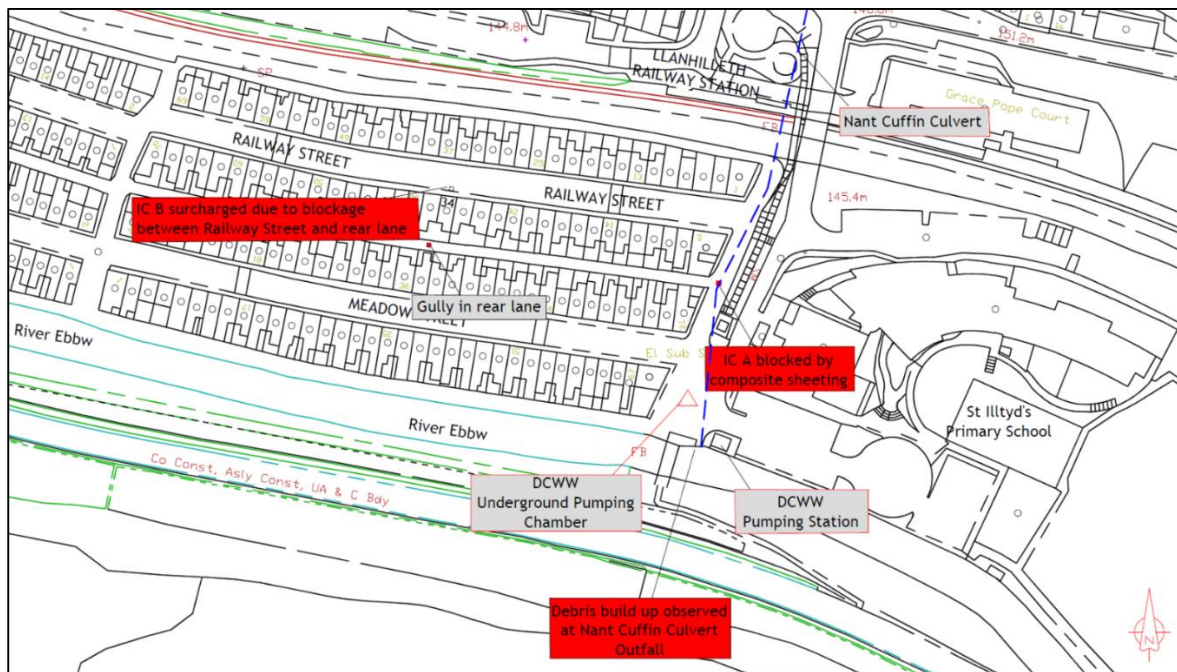
Figure 6 below shows the three areas within the study area where drainage issues were recorded during Storm Dennis

Figure 6 Site of recorded drainage issues within study site

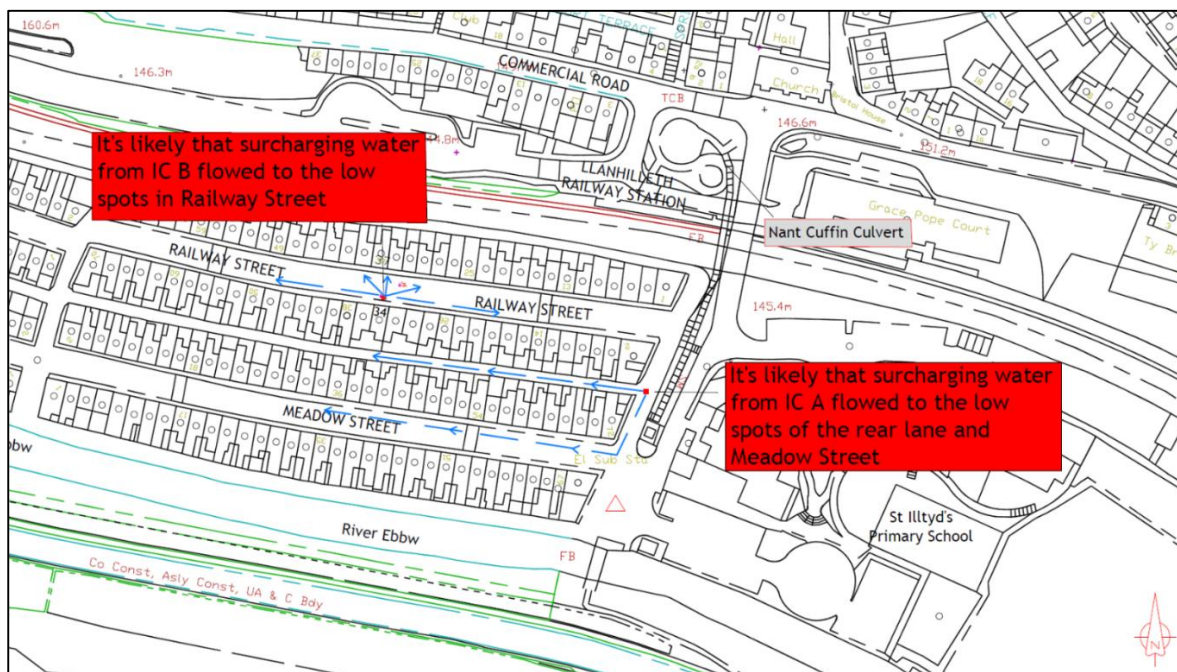
Figure 7 below shows the likely flow paths of the surcharging water during Storm Dennis based on the topography of the streets.

Figure 7 Likely directional flow of surcharging storm water

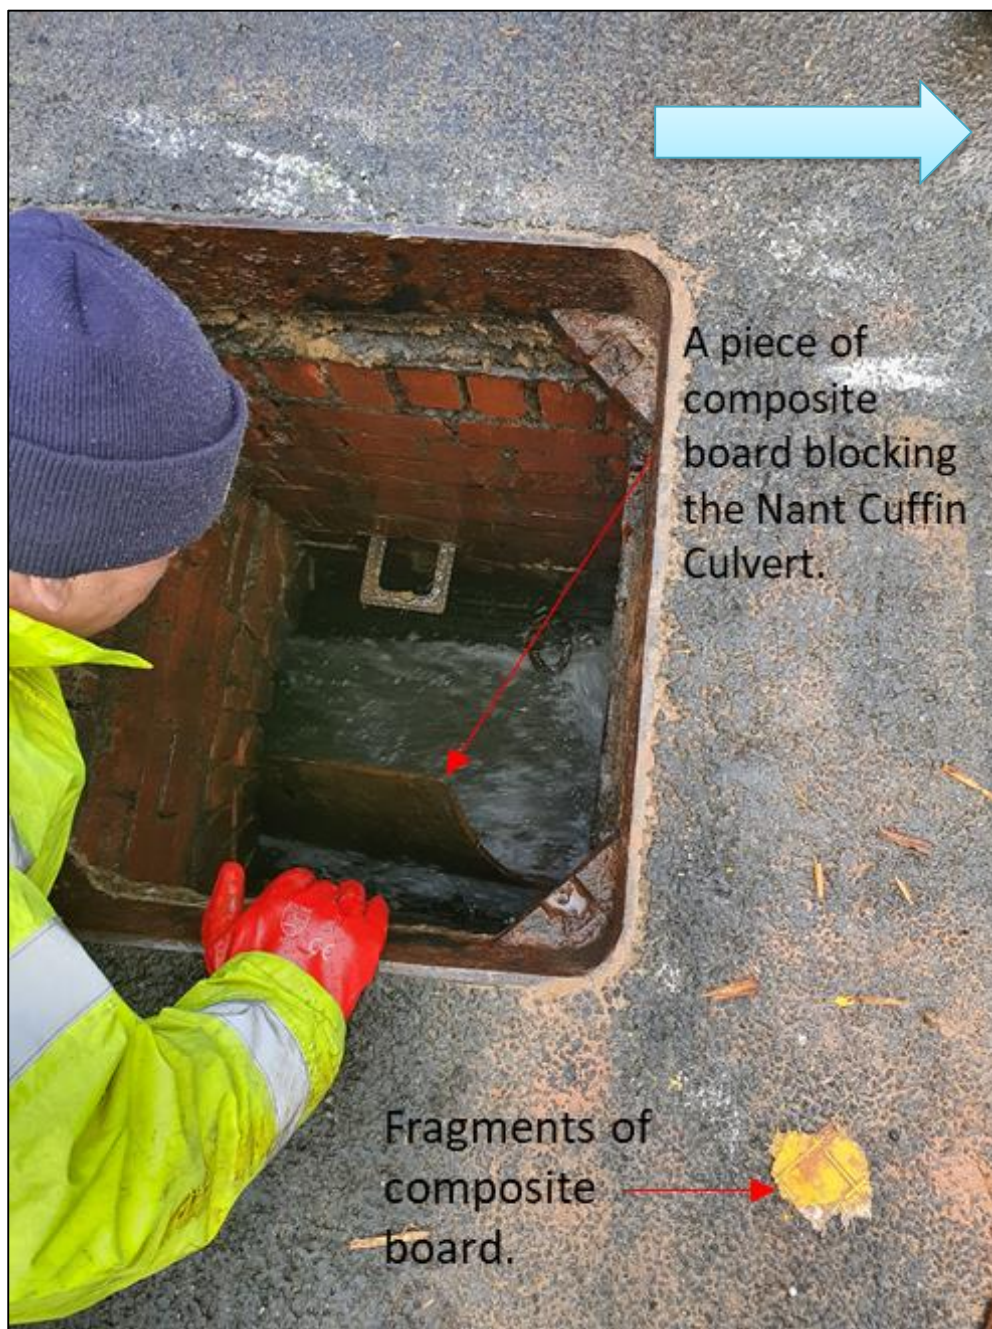
A large piece of composite board was found in the main storm water culvert underneath eastern link road between Meadow Street and Railway Street. The board caused a partial blockage in the culvert and the force of the water surcharging from the inspection chamber 'blew the cover off' according to one eye witness. The surcharging water discharged from the inspection chamber, which has a ground level of 140.48m AOD, and quickly flowed towards the low points in the rear lane and Meadow Street, which has a low point of 139.08 m

AOD further adding to the high volume of surface water caused by the exceptional rainfall. For the purposes of the report, this inspection chamber is referred to as IC A.

*Photograph 1 Blocked inspection chamber of the Nant Cuffin Culvert, located to the east of the rear lane between Meadow Street and Railway Street. The blockage can be seen inside the chamber, with fragments of it on the surrounding road. Attempts to remove the blockage could only be made once it was safe enough to do so. Arrow shows direction of flow-south towards River Ebbw (February 2020)*

The blockage was removed by a member of BGCBC's drainage team once the flow of water in the chamber had subsided enough to enable it to be safely extracted.

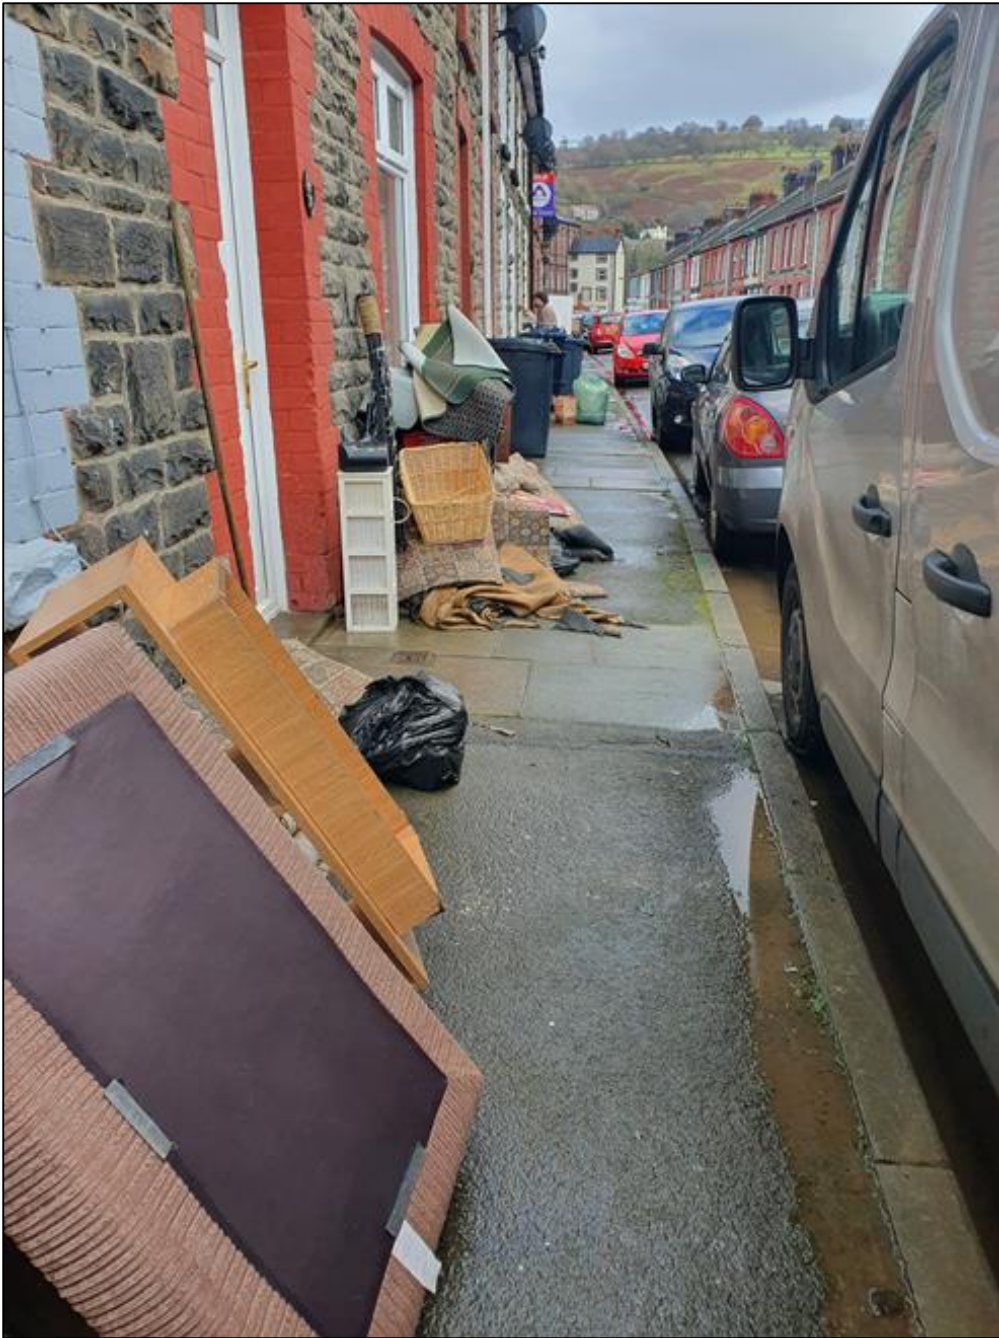
*Photograph 2 Damaged contents outside homes along Meadow Street, Llanhilleth following Storm Dennis. View East. (February 2020).*

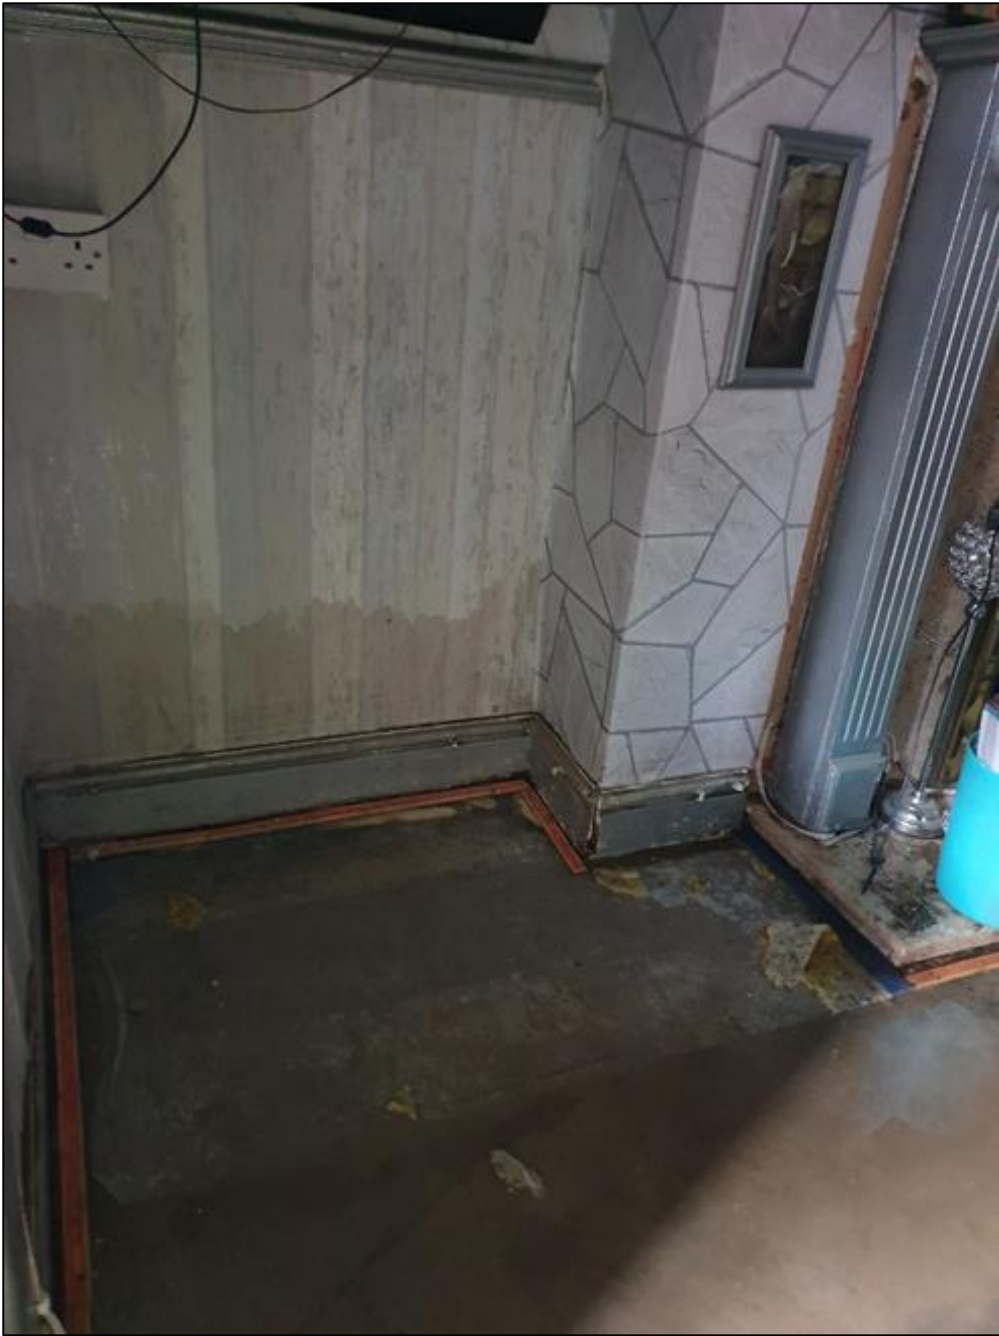
*Photograph 3 Flood damaged living room of property in Meadow Street. Damaged carpets have been removed and the water mark left by the flood waters can clearly be seen. (February 2020).*

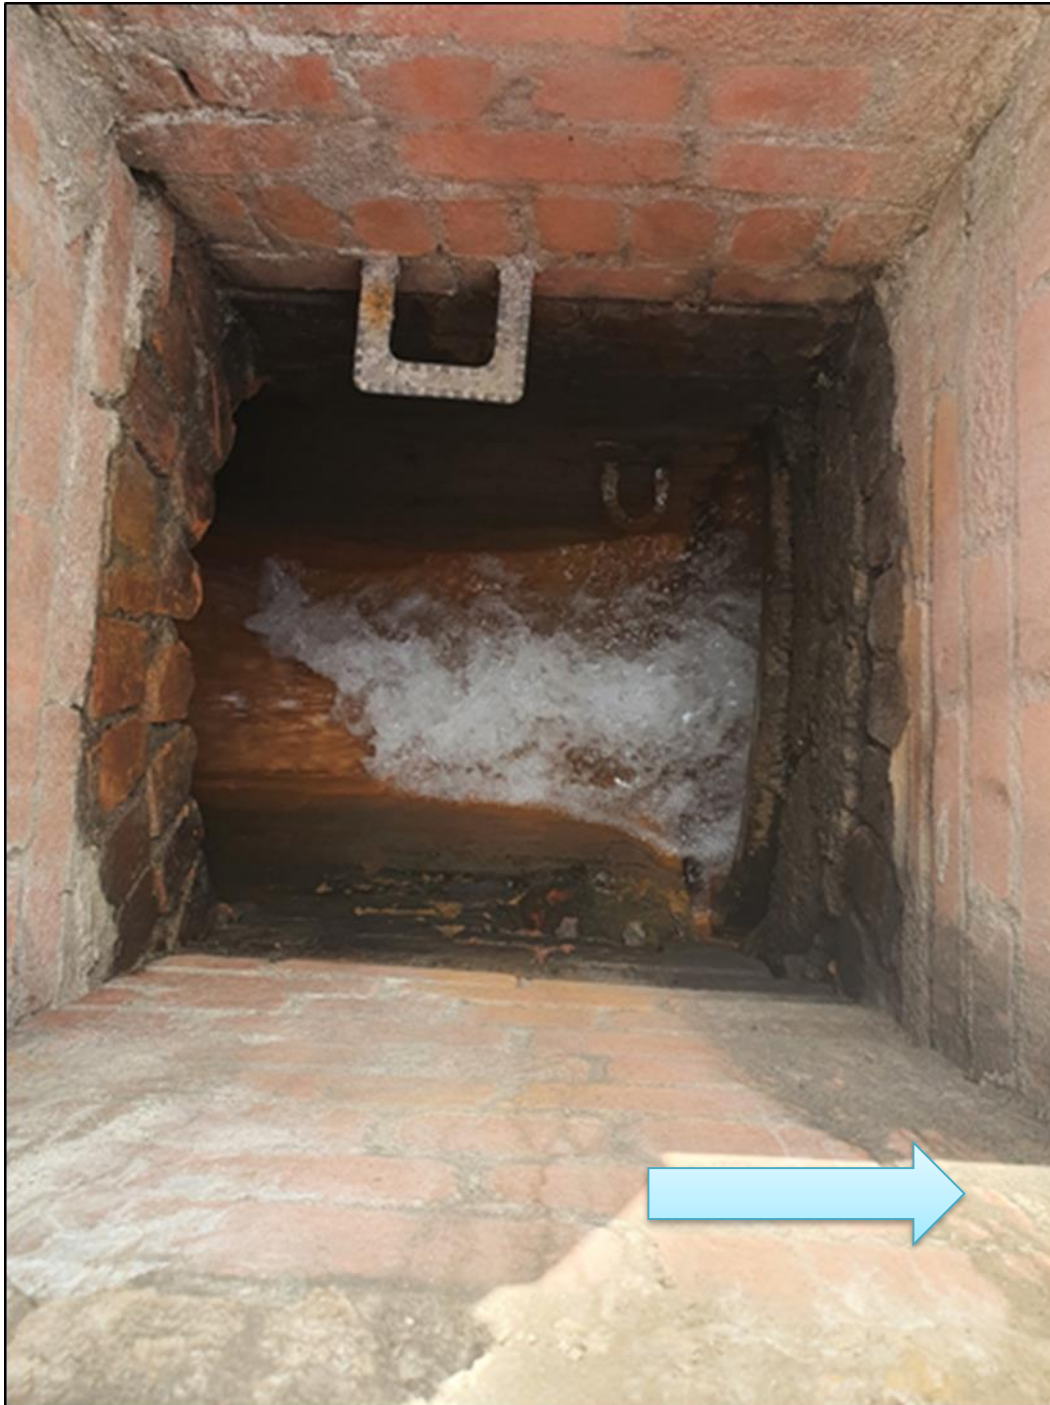
*Photograph 4 View of inside inspection chamber that was blocked during Storm Dennis. Arrow shows direction of flow of water. Water is flowing freely and unobstructed. (June 2021)*

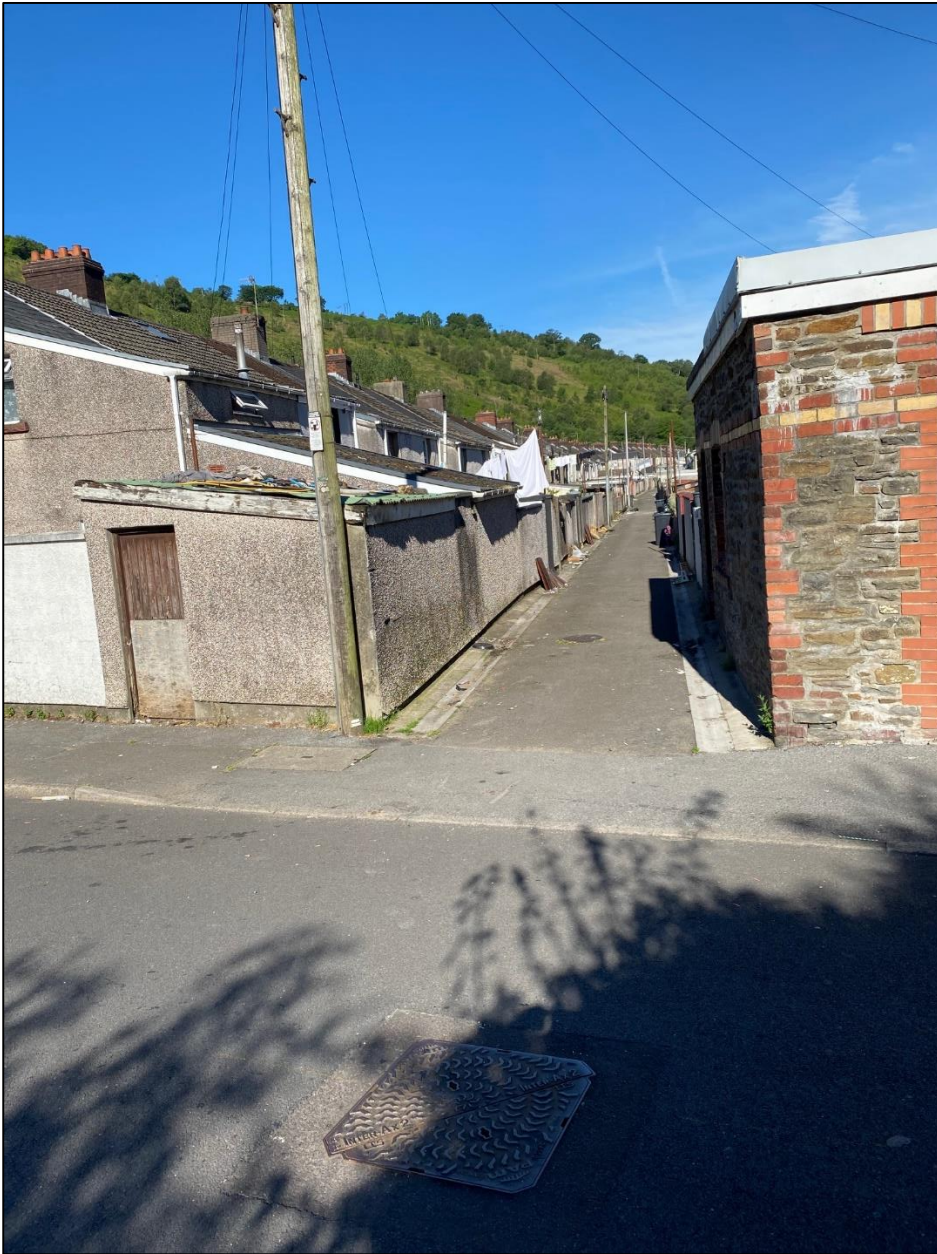
*Photograph 5 Rear Lane between Meadow Street and Railway Street. Manhole that was blocked by composite board during Storm Dennis at forefront of photograph. View West. (June 2021)*

The cover of the manhole chamber, located to the east of the rear lane, which was dislodged by the sheer force of the surcharging water caused by a blockage, was replaced by Blaenau Gwent CBC soon after the storm event had passed.

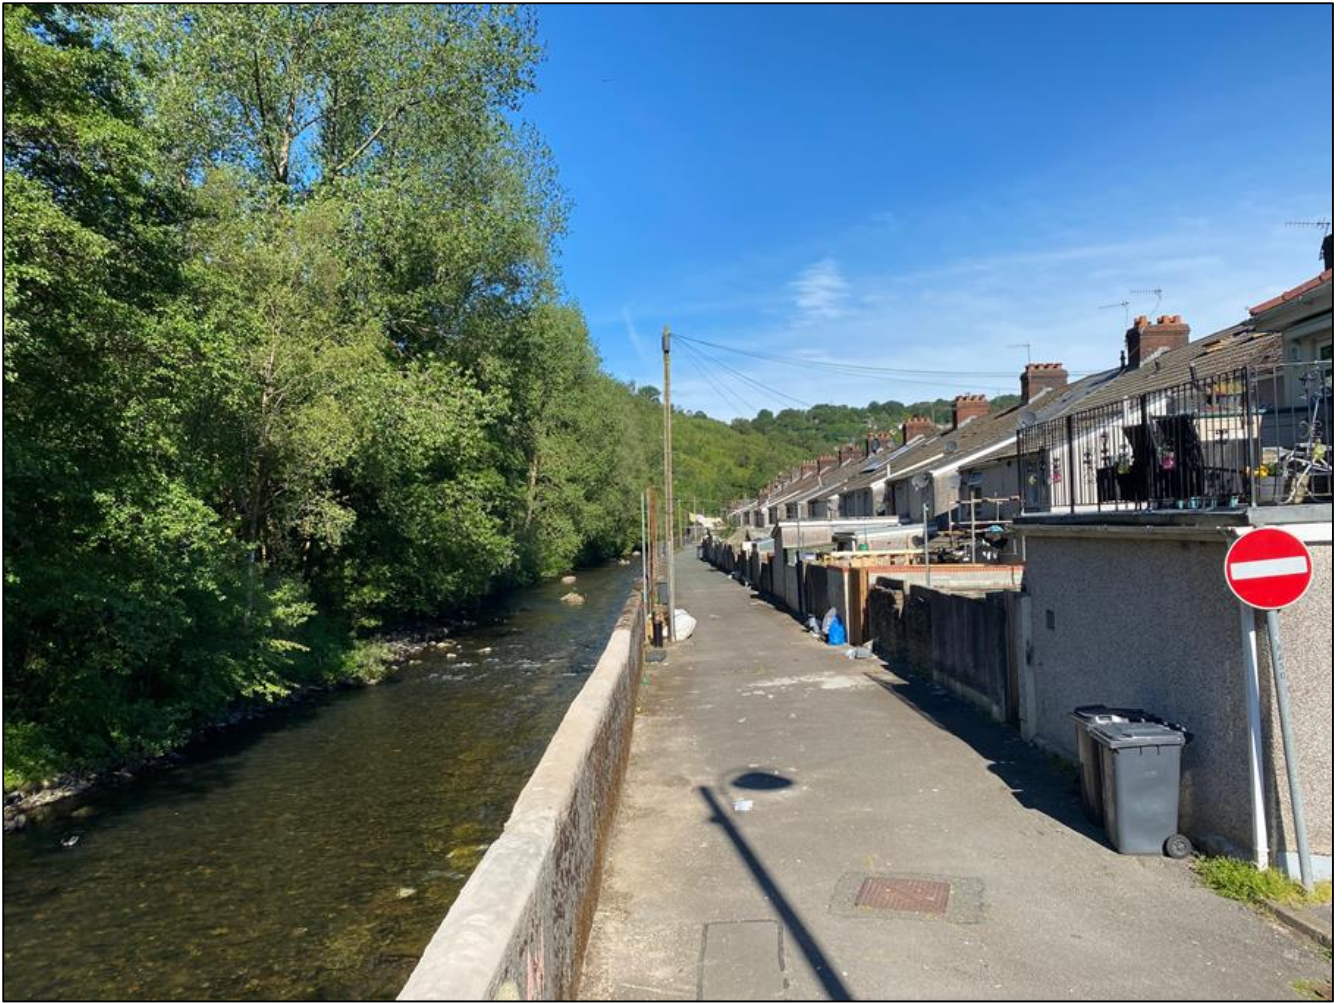
*Photograph 8 Rear of Meadow Street along the bank of the River Ebbw. NRW's flood defence wall protected the street from fluvial flooding. View West. (June 2021).*

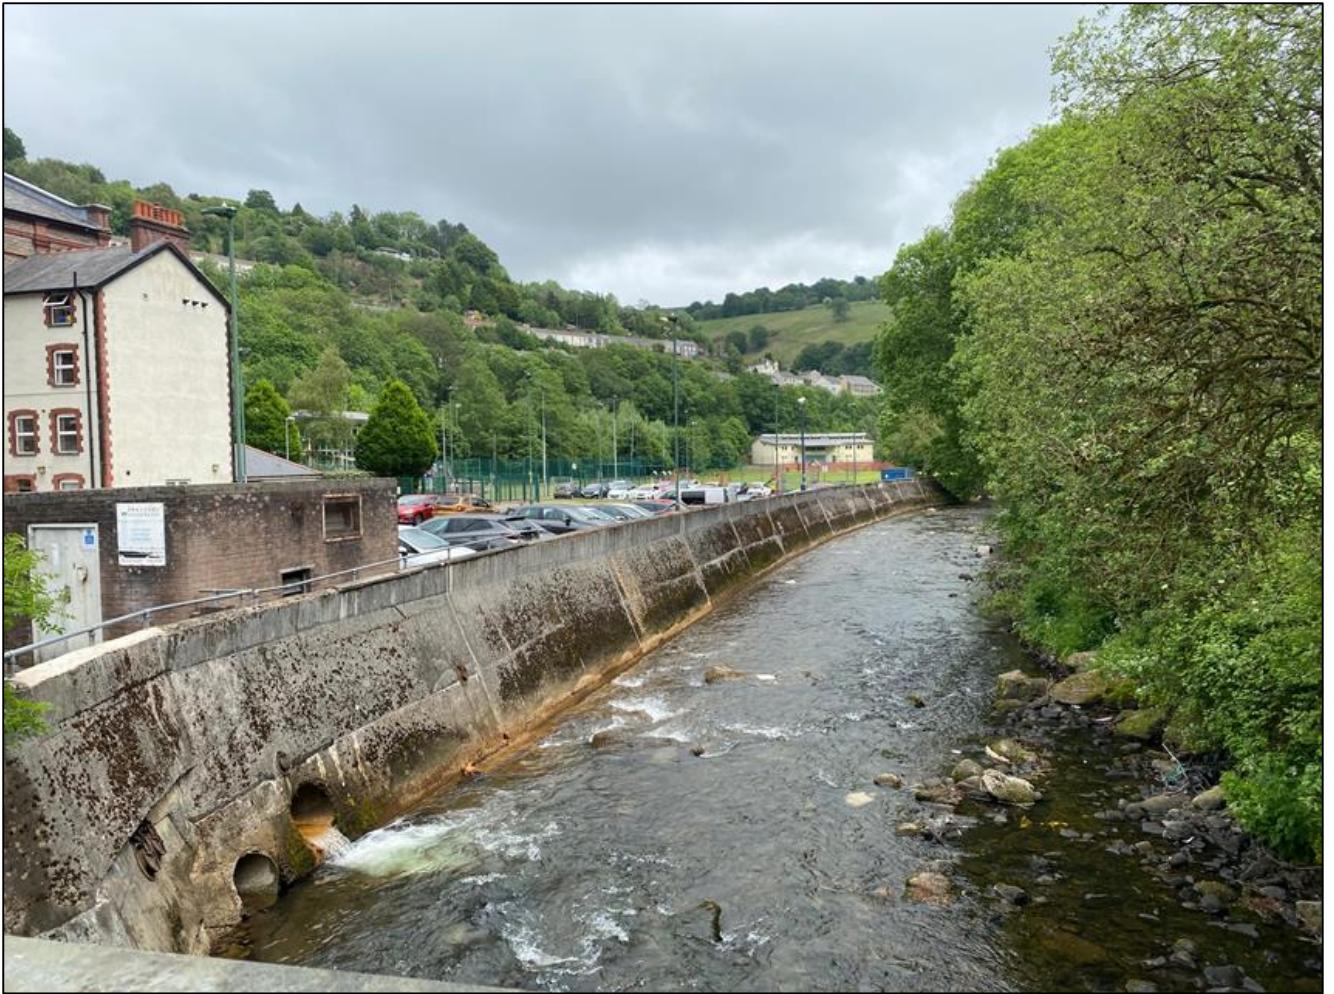
The report also notes that the culvert flowing into the pumping station was full of debris, which built up in the outfall, prohibiting the free flow of water away from the pumping station. The site photographs taken of the culvert outfall show a mass of silt and small stones in the culvert, which led to loss of capacity. A copy of the report can be found in Appendix B of this report.

*Photograph 9 The River Ebbw flowing in a south easterly direction. At the bottom lh side of the picture is the outfall of the Nant Cuffin Culvert and pumping station inlet. Above the outlet is DCWW's pumping Station building. In the distance is the car park for St Illtyd's Primary School and Llanhilleth's Recreation Ground. (June 2021).*

The Nant Cuffin Culvert inlets and trash screens will continue to be regularly inspected to check for debris build up. Any visible debris will need to be removed to help ensure the full capacity of the culvert is maintained and to avoid any blockages and surcharges further downstream.
