Brief

The purpose of this report is to carry out a condition survey of Brynmawr Community Centre following reports of unsafe work being carried out, on arrival it was immediately apparent that there are live electrical cables in the foyer and throughout the building that pose an immediate danger to occupants and members of the public, which leaves the authority in no doubt that this building should be immediately closed down. An electrical and gas periodic test needs to be carried at the earliest date possible to establish the full extent of the damage.

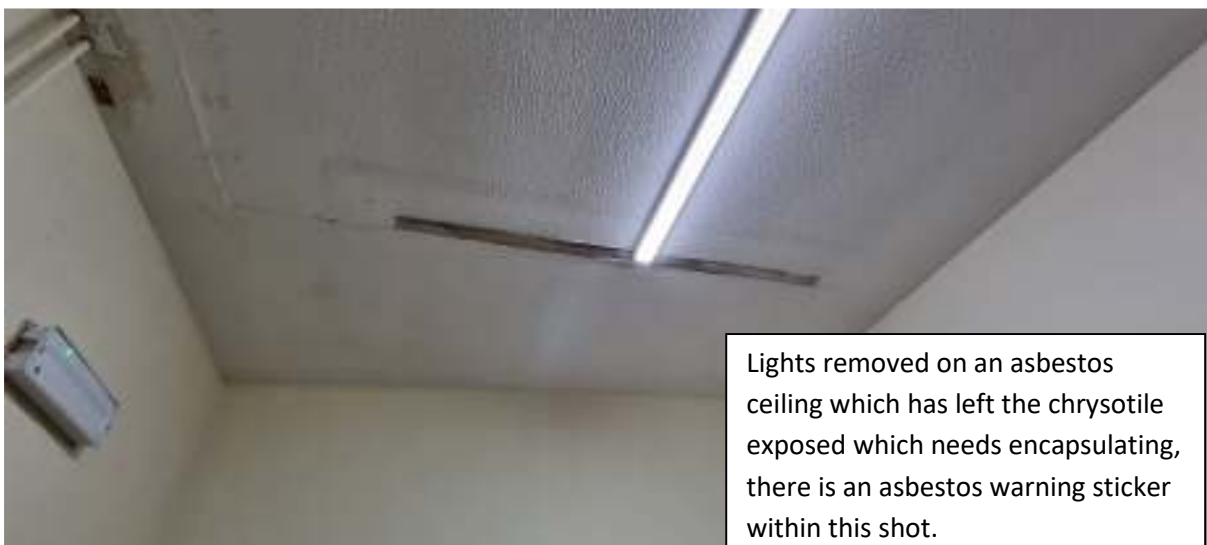
Lights removed on an asbestos ceiling which has left the chrysotile exposed which needs encapsulating, there is an asbestos warning sticker within this shot.

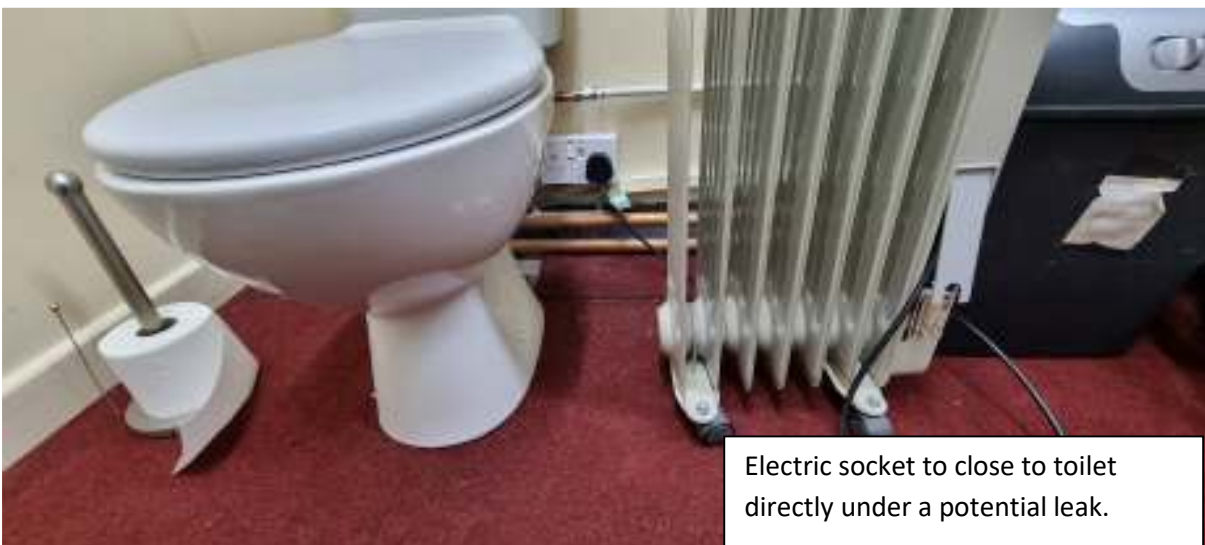
Electric socket too close to toilet directly under a potential leak.

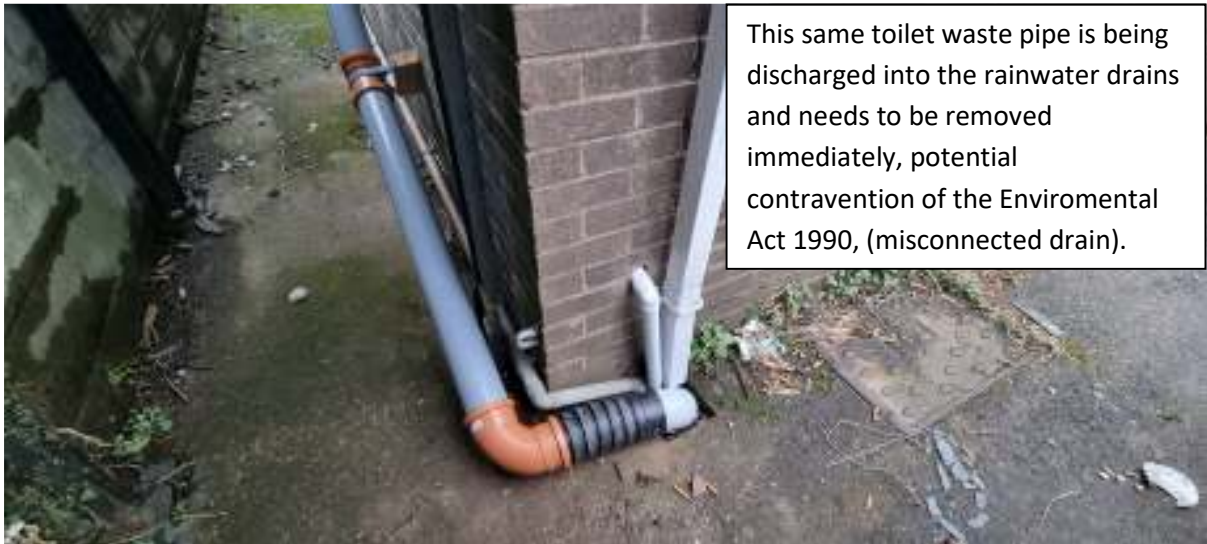
This same toilet waste pipe is being discharged into the rainwater drains and needs to be removed immediately, potential contravention of the Enviromental Act 1990, (misconnected drain).

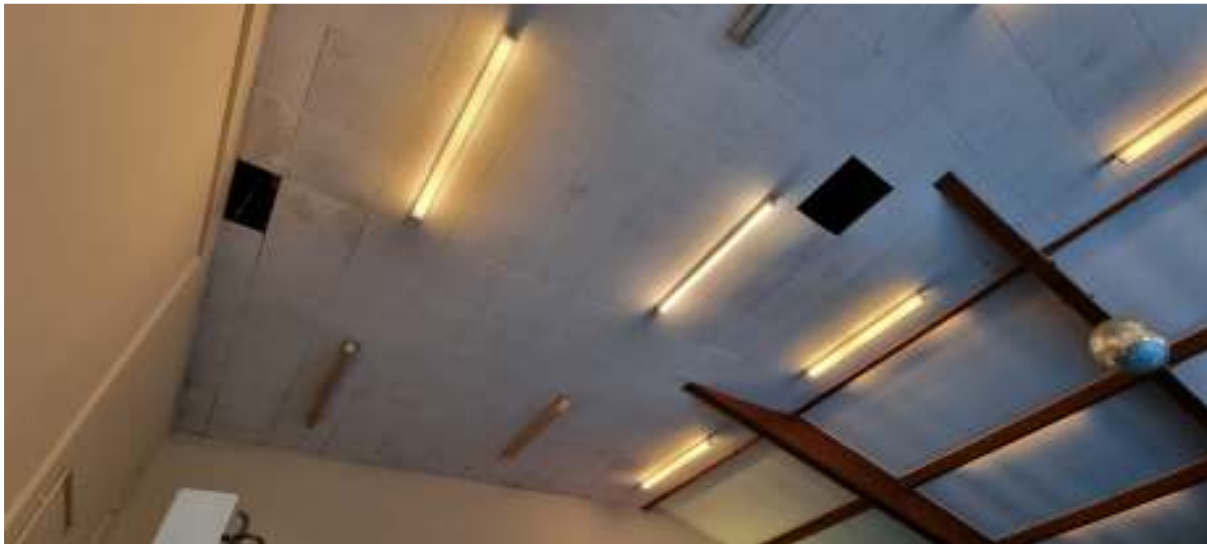
This suspended ceiling has tiles that have fallen and should be replaced, the issue the authority will have is that the boxing gym that is directly below and in the way for any work.

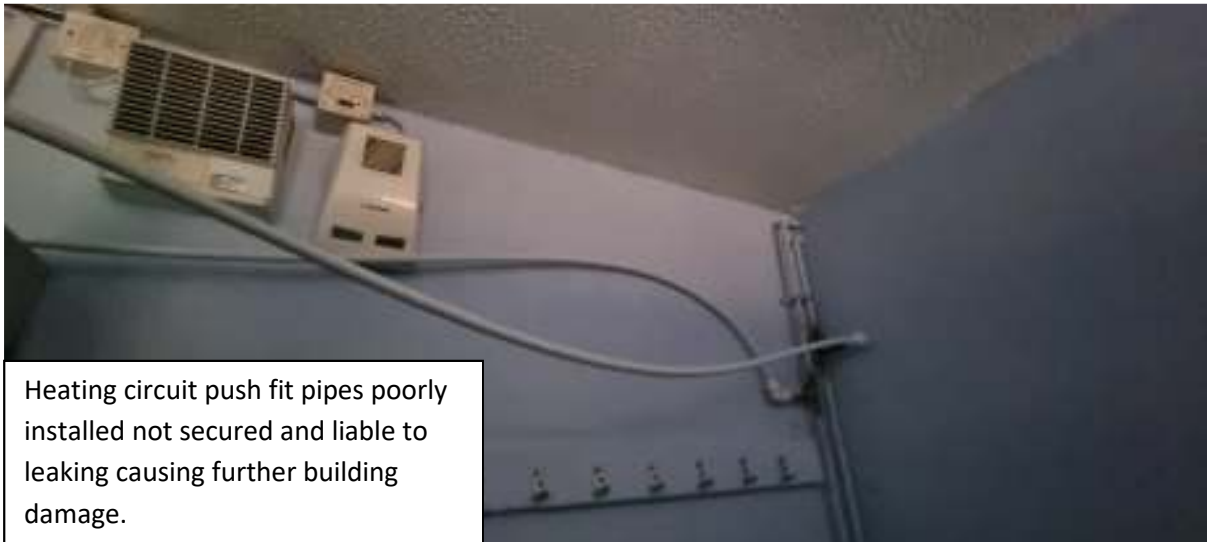
Heating circuit push fit pipes poorly installed not secured and liable to leaking causing further building damage.

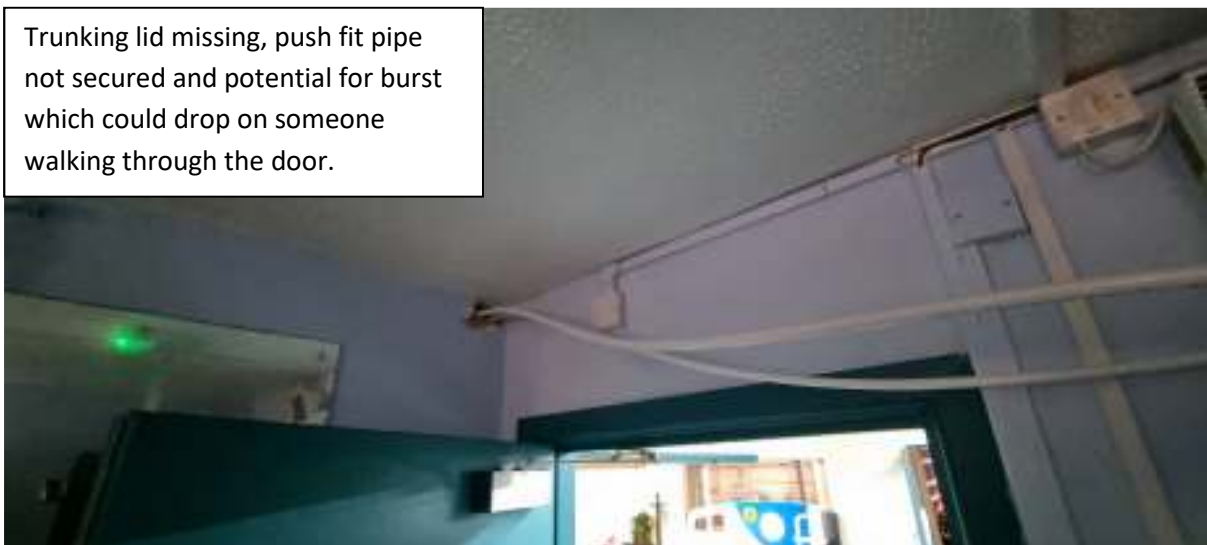
Trunking lid missing, push fit pipe not secured and potential for burst which could drop on someone walking through the door.

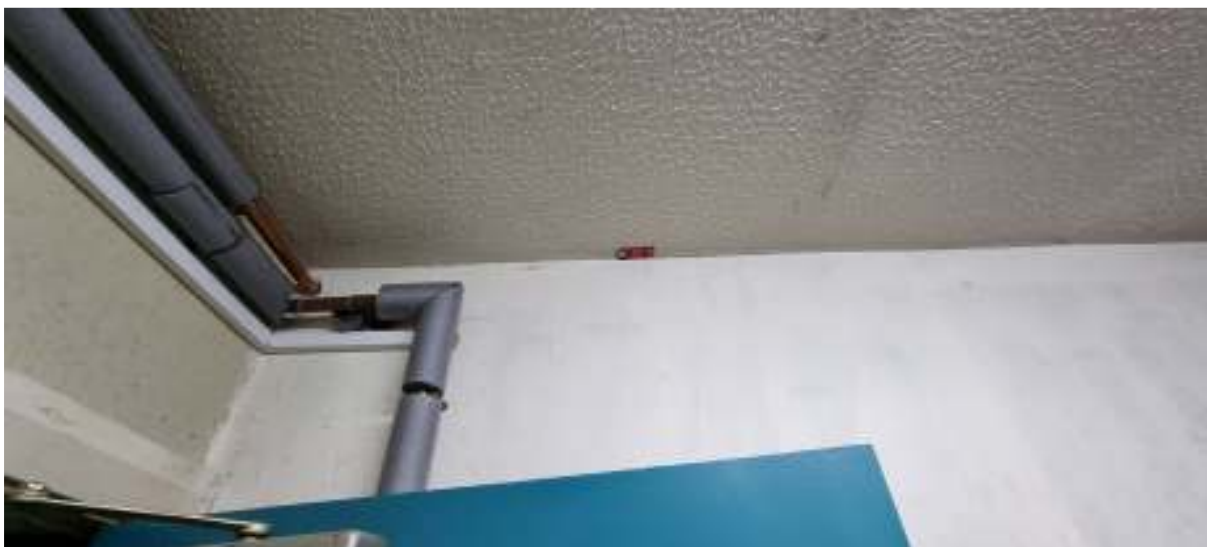
Evidence of electrical alterations no electrical safety certification provided to technical services.

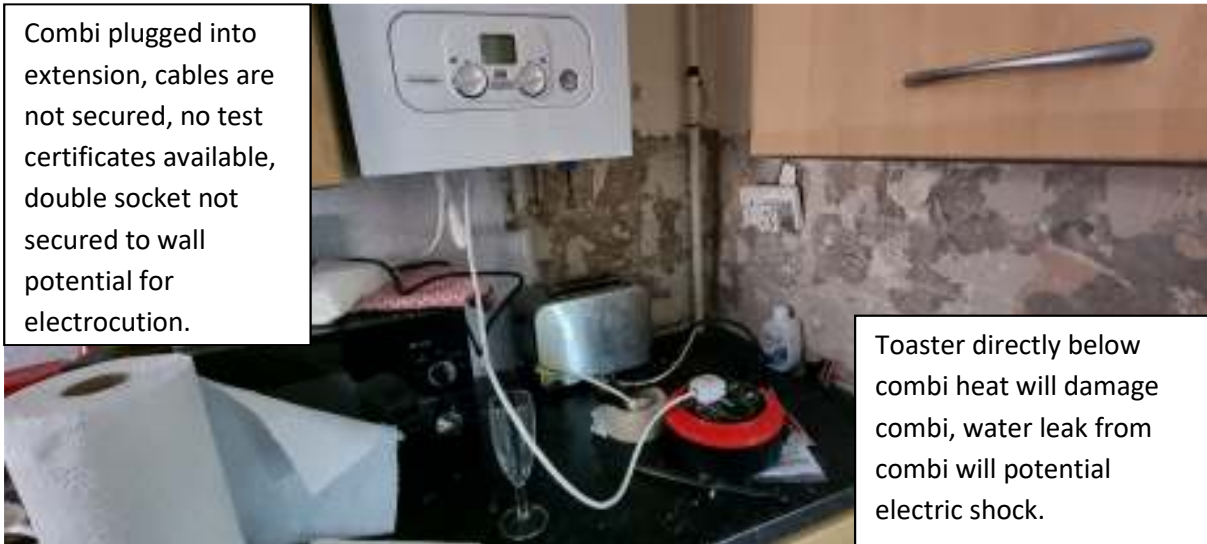
Toaster directly below combi heat will damage combi, water leak from combi will potential electric shock.

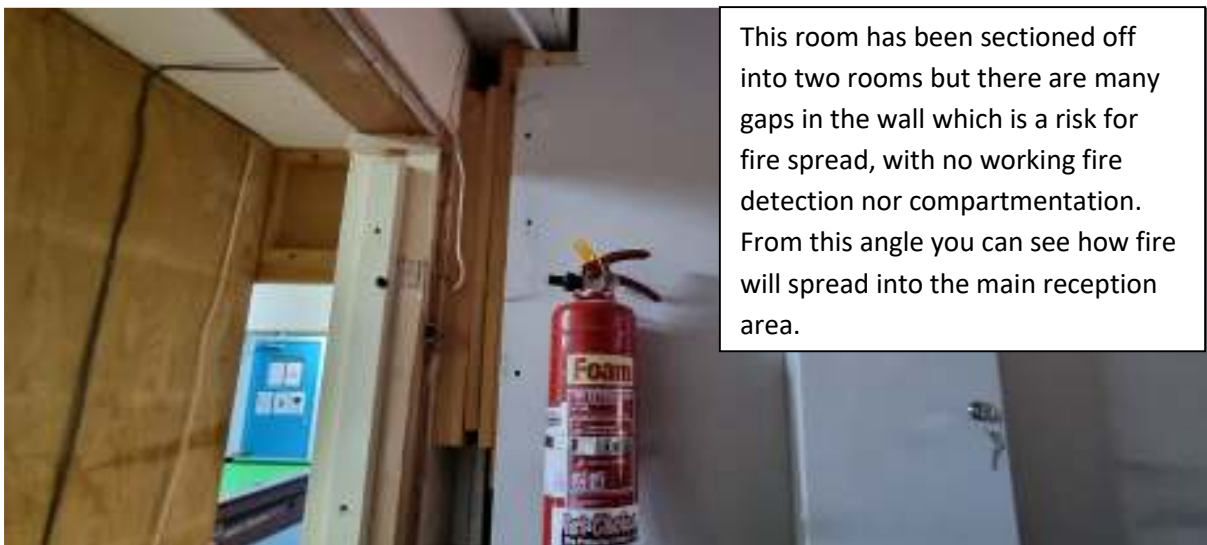
This room has been sectioned off into two rooms but there are many gaps in the wall which is a risk for fire spread, with no working fire detection nor compartmentation. From this angle you can see how fire will spread into the main reception area.

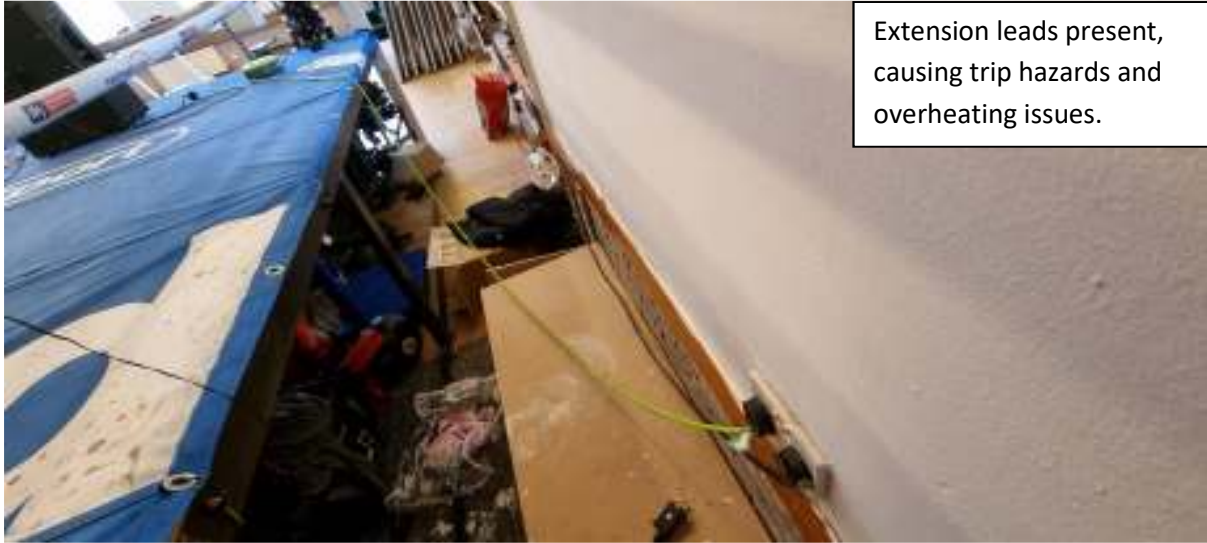
Extension leads present, causing trip hazards and overheating issues.

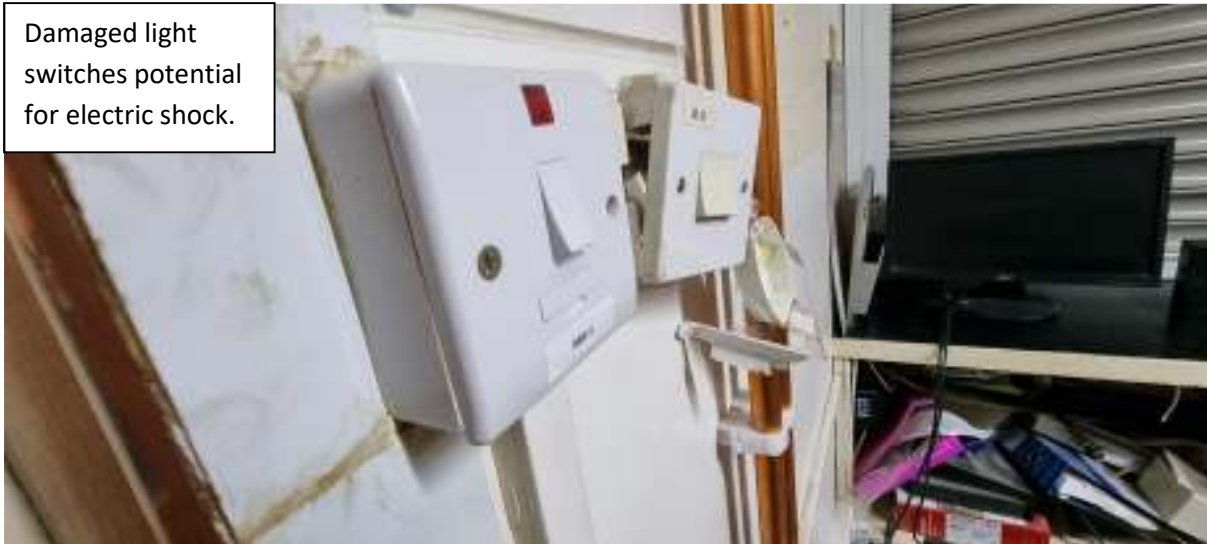
Damaged light switches potential for electric shock.

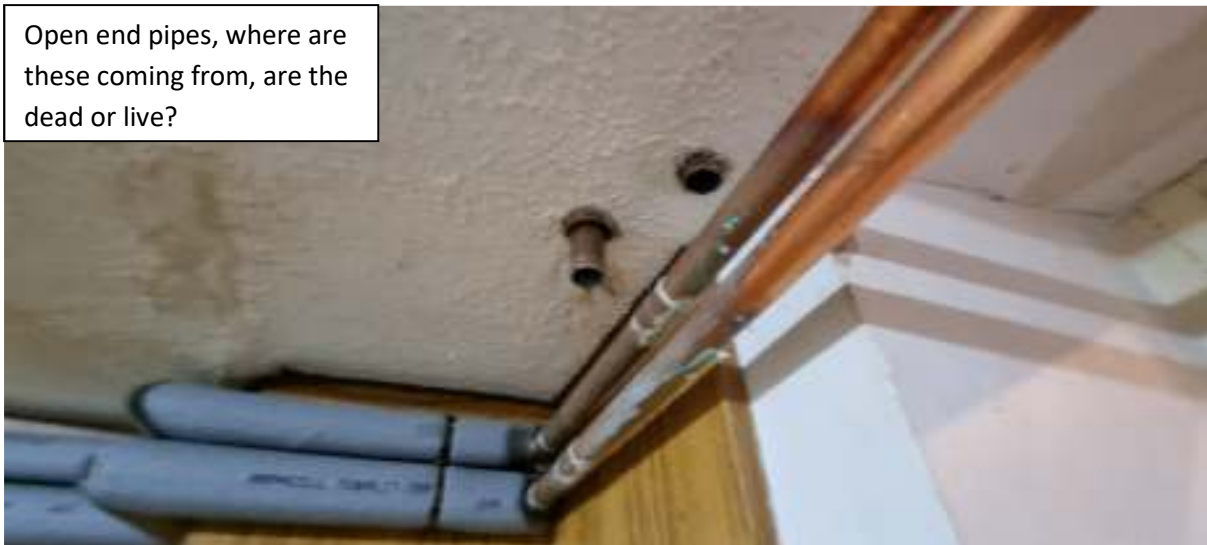
Open end pipes, where are these coming from, are the dead or live?

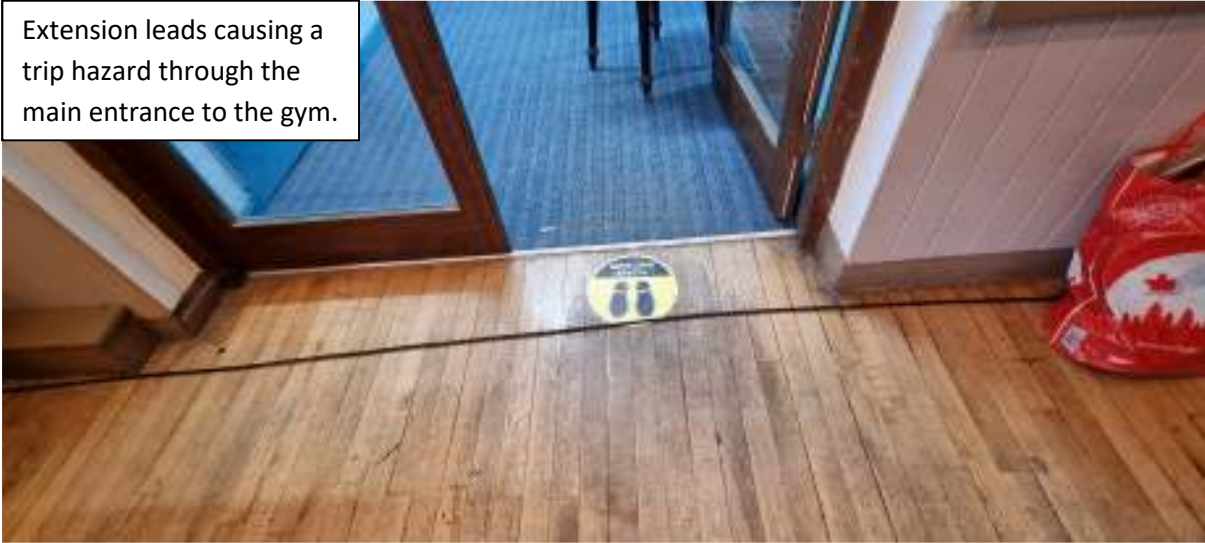
Extension leads.

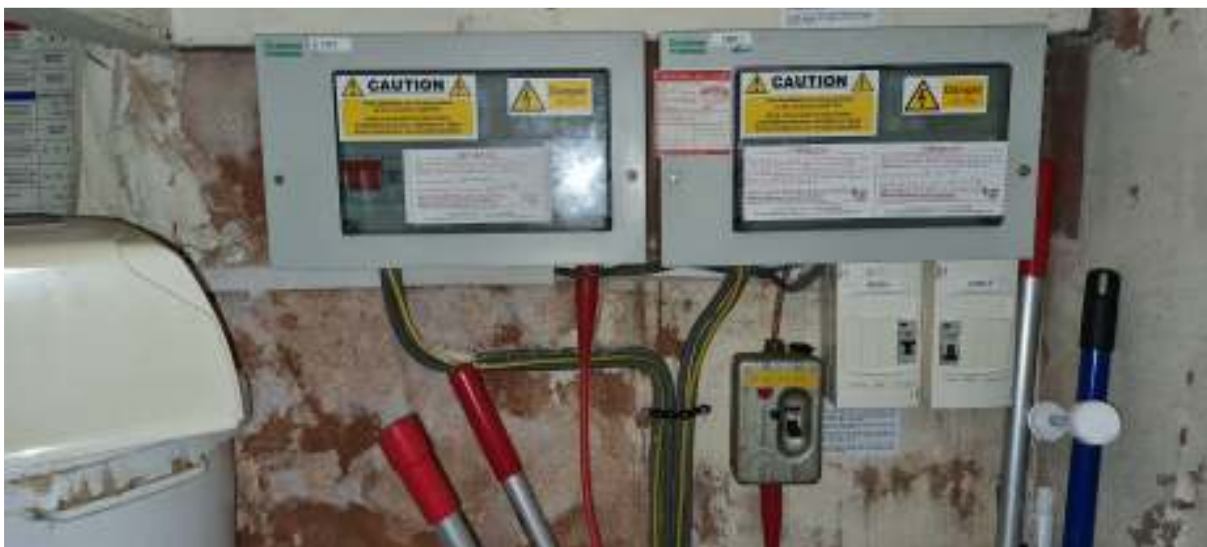
Mains room being used to store combustibles.

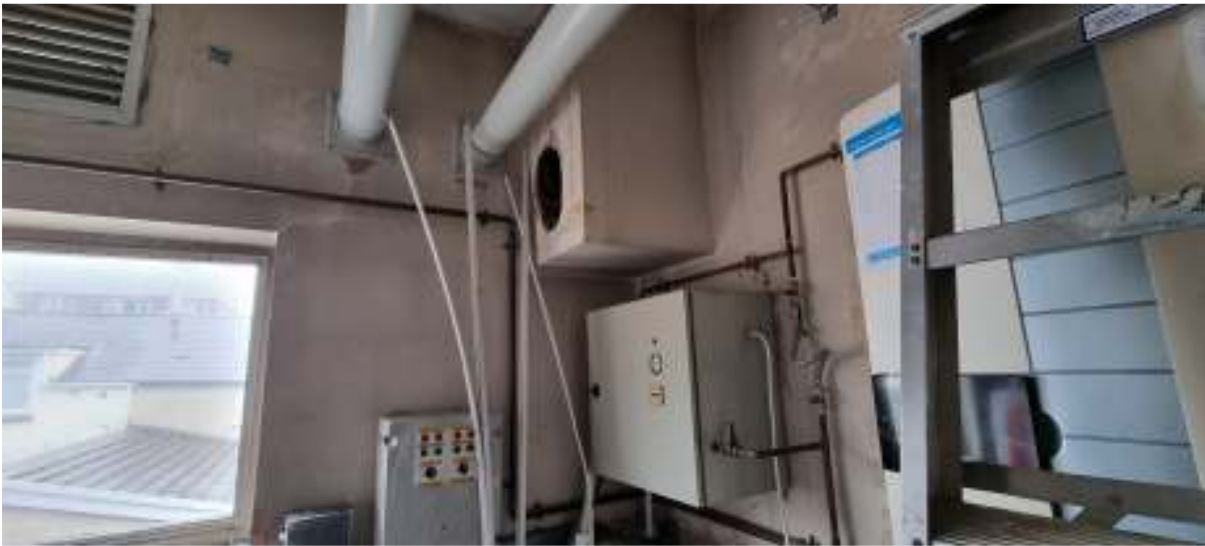
What appears to be redundant plant and pipe work left in situ, potential legionnaires risk, gas leak.

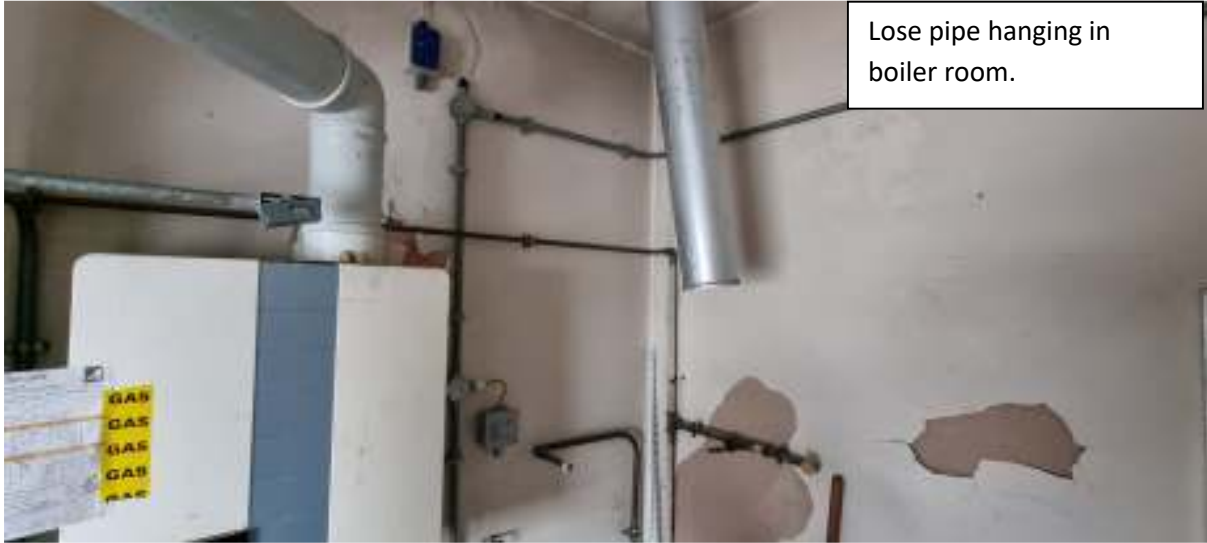
Lose pipe hanging in boiler room.

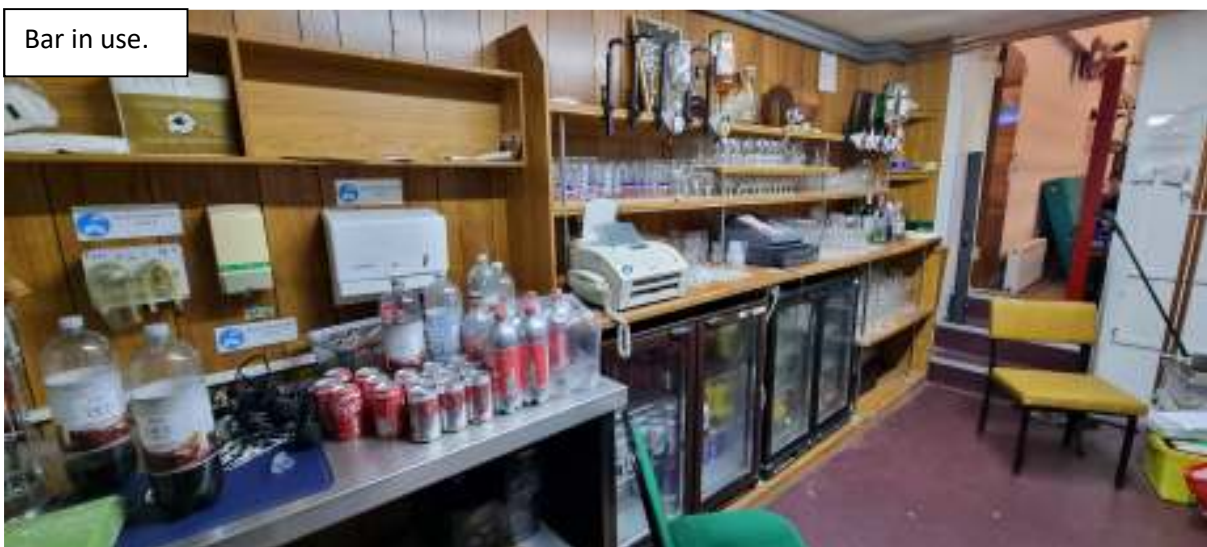
Bar in use.

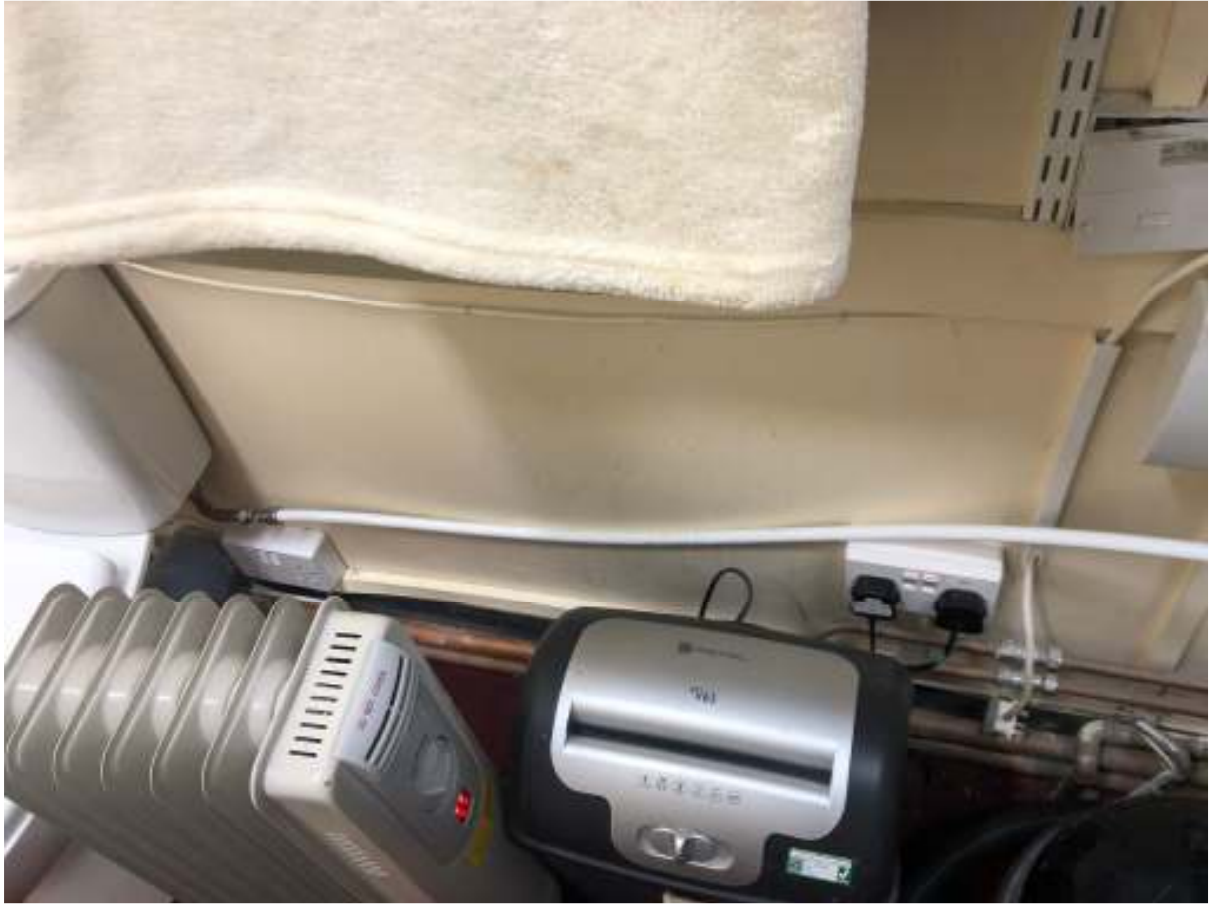
Alarm system appears disconnected/redundant. New unit installed by kitchen downstairs.

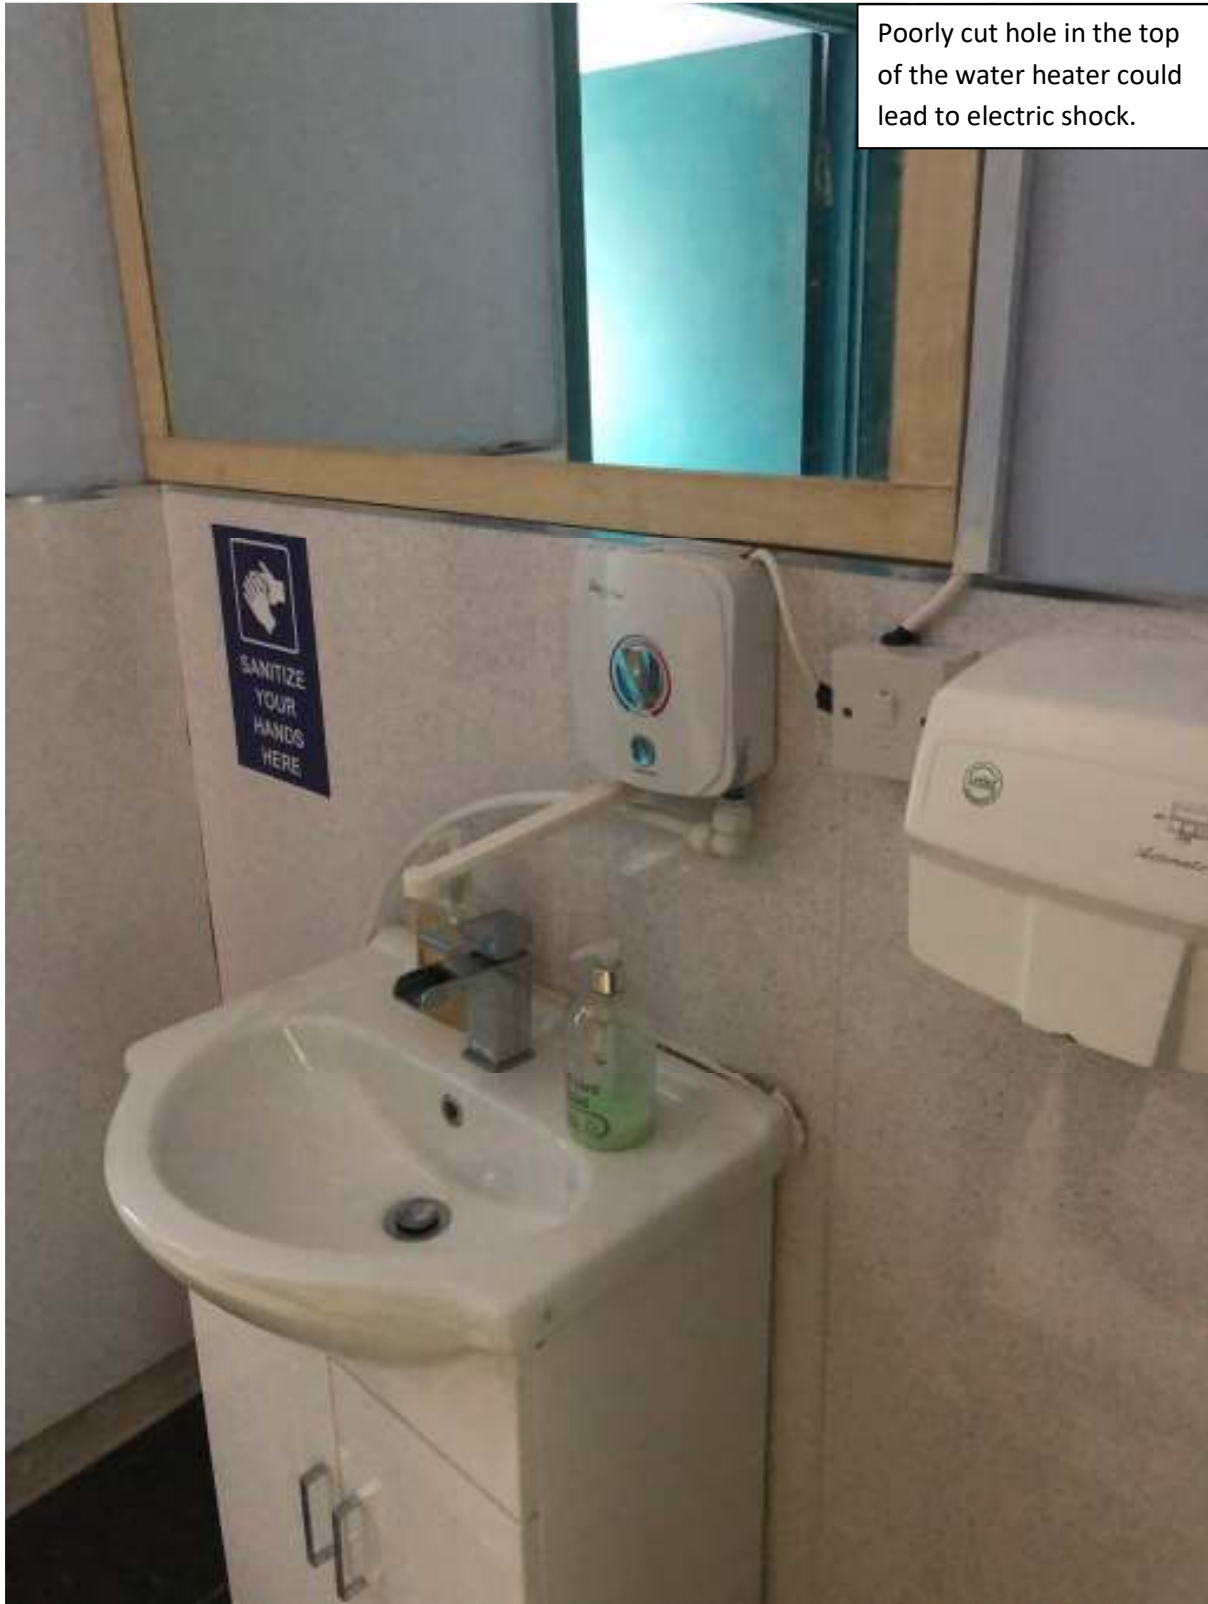
Poorly cut hole in the top of the water heater could lead to electric shock.

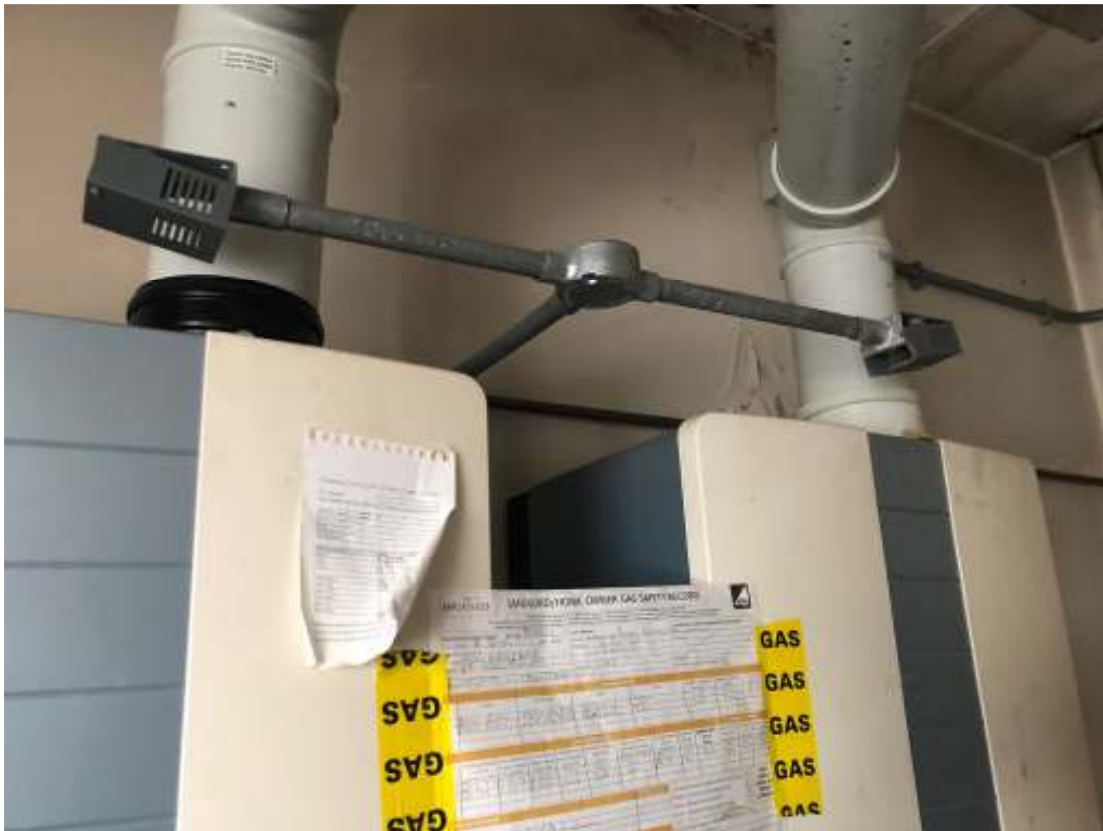
Second poorly installed
water heater, cables no
protection cores visible.
