Brief

The purpose of this report is to carry out a condition survey of Brynmawr Community Centre following reports of unsafe work being carried out, on arrival it was immediately apparent that there are live electrical cables in the foyer and throughout the building that pose an immediate danger to occupants and members of the public, which leaves the authority in no doubt that this building should be immediately closed down. An electrical and gas periodic test needs to be carried at the earliest date possible to establish the full extent of the damage.

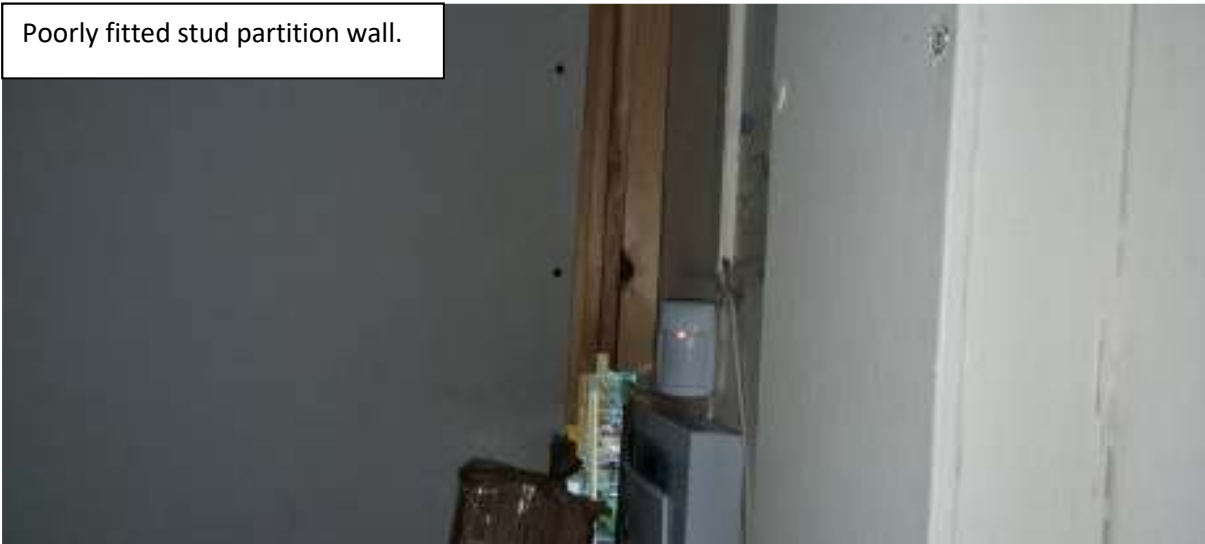
Poorly fitted stud partition wall which has gaps into the new kitchen with no working fire detection nor fire compartmentation. If a fire started in the kitchen it would spread quickly through the building.

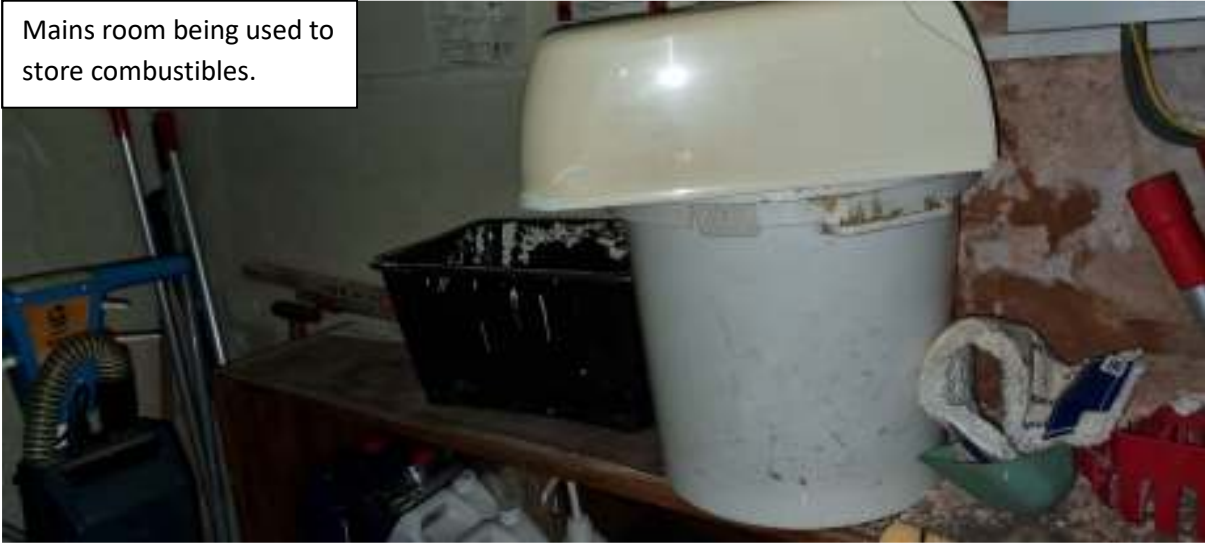
Mains room being used to store combustibles.

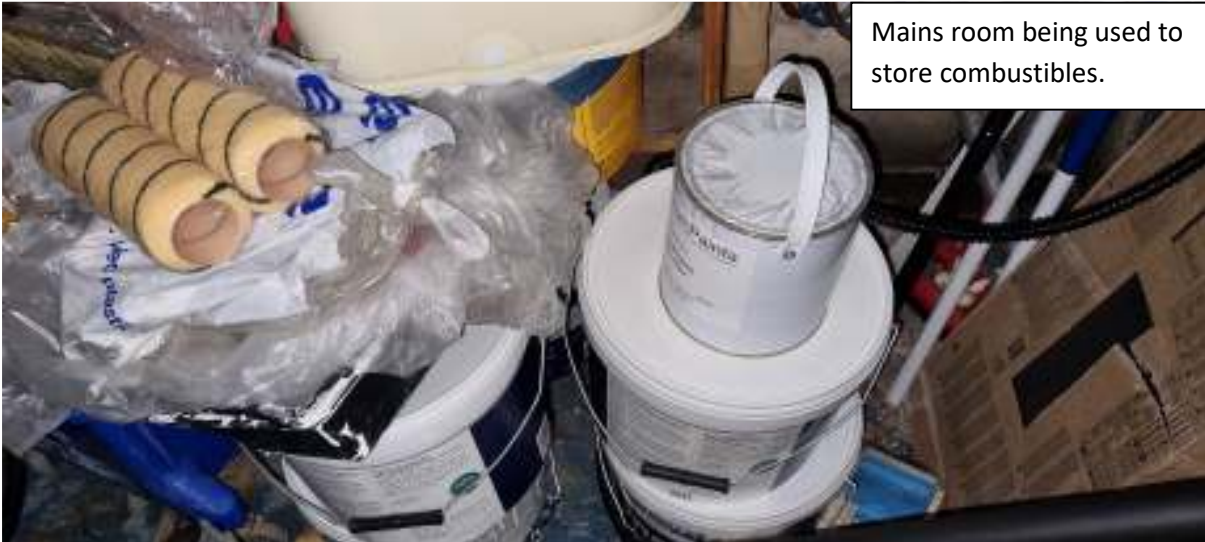
Mains room being used to store combustibles.
