Brief

The purpose of this report is to carry out a condition survey of Brynmawr Community Centre following reports of unsafe work being carried out, on arrival it was immediately apparent that there are live electrical cables in the foyer and throughout the building that pose an immediate danger to occupants and members of the public, which leaves the authority in no doubt that this building should be immediately closed down. An electrical and gas periodic test needs to be carried at the earliest date possible to establish the full extent of the damage.

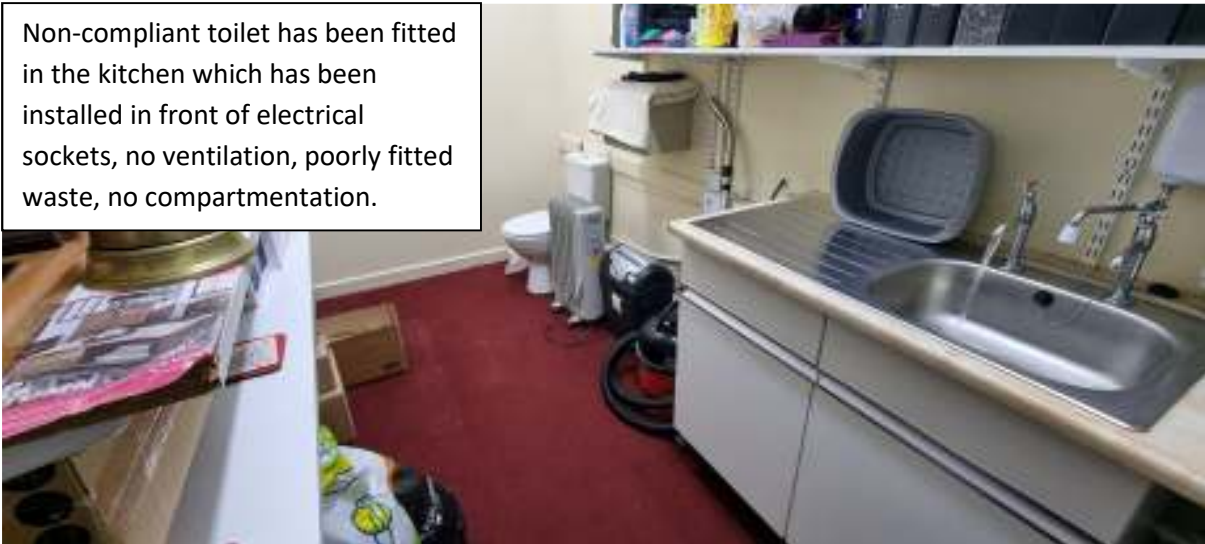
Electric socket too close to toilet directly under a potential leak.

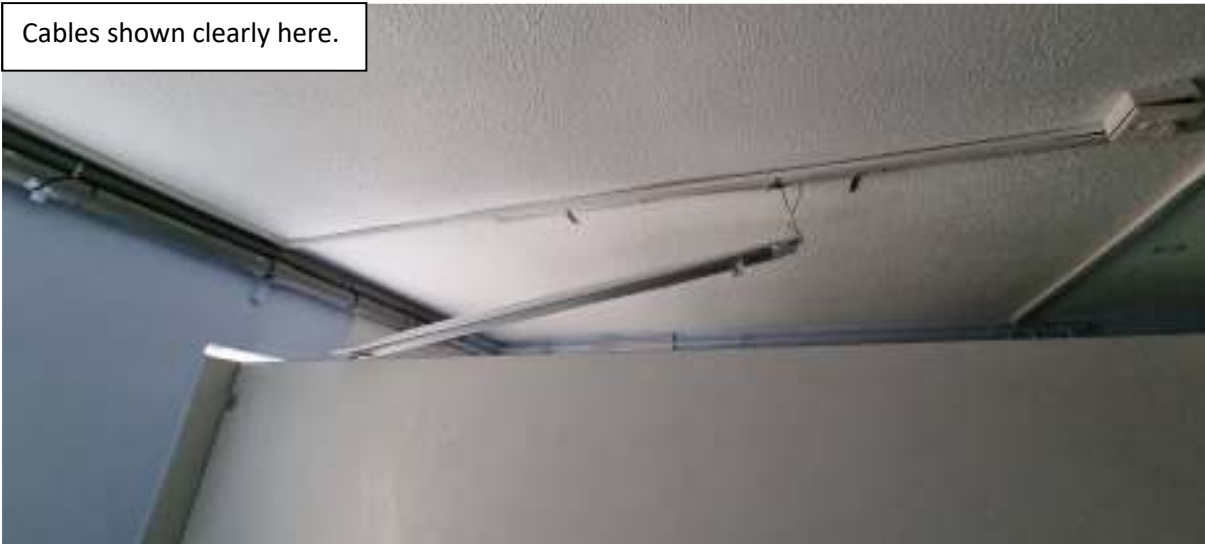
Cables shown clearly here.

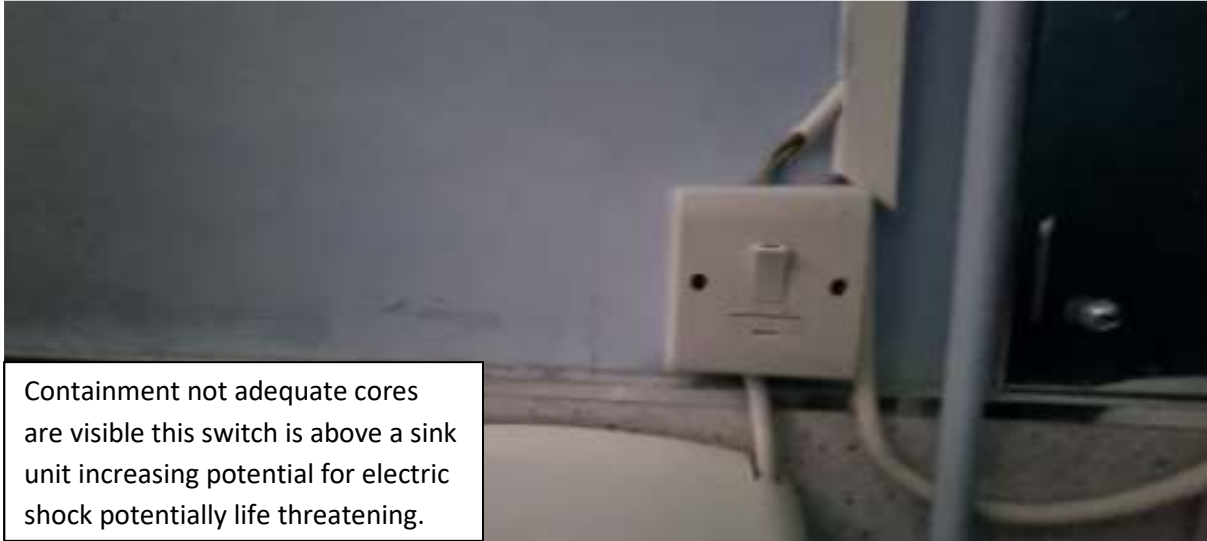
Containment not adequate cores are visible this switch is above a sink unit increasing potential for electric shock potentially life threatening.

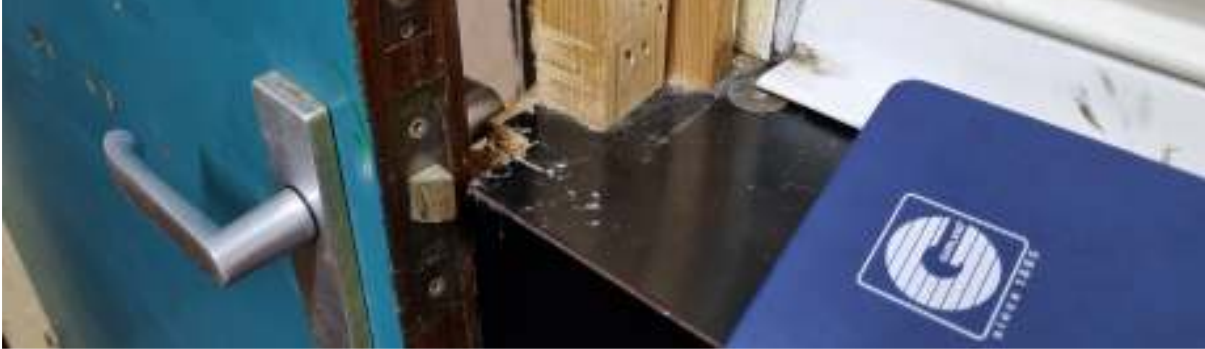
This is the main fire door into the open bar/kitchen area which is bigger than the door opening and provides no fire protection/compartimentation at all, extremely dangerous.

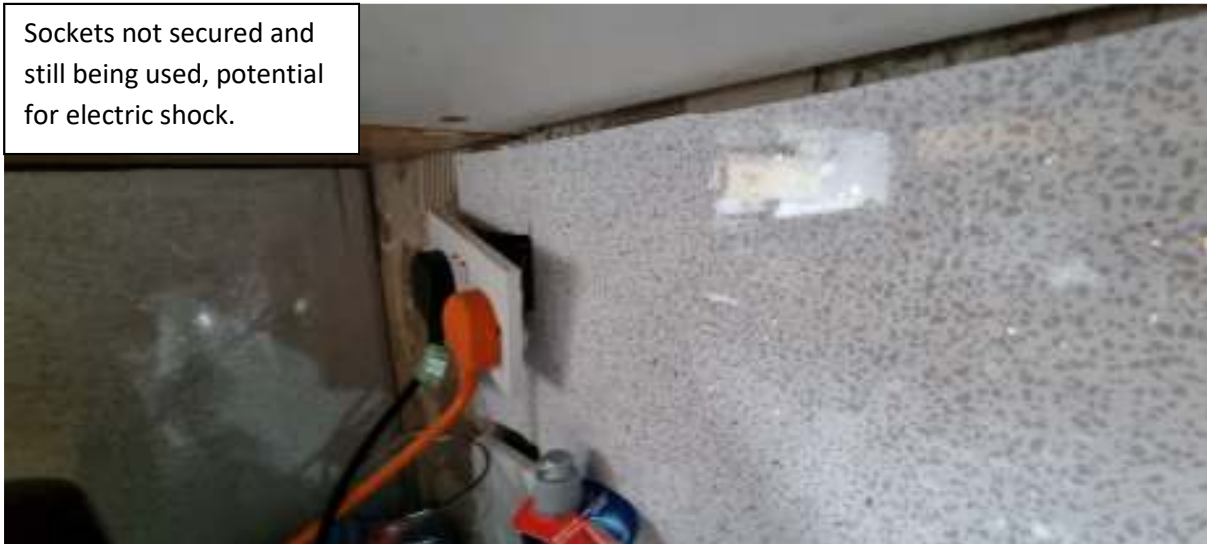
Extension leads being used to supply power.

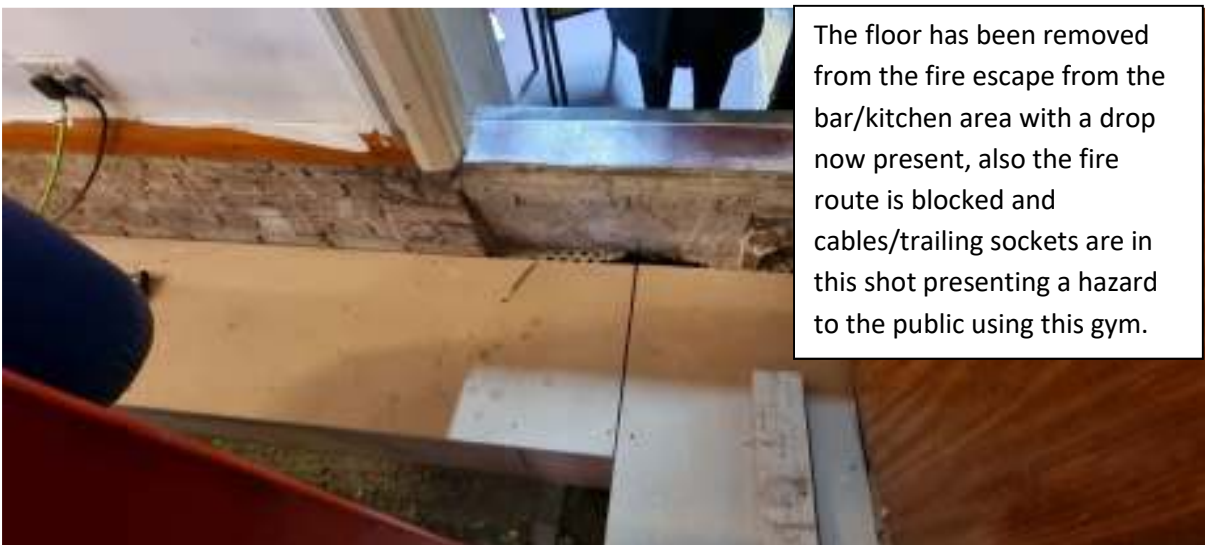
The floor has been removed from the fire escape from the bar/kitchen area with a drop now present, also the fire route is blocked and cables/trailing sockets are in this shot presenting a hazard to the public using this gym.

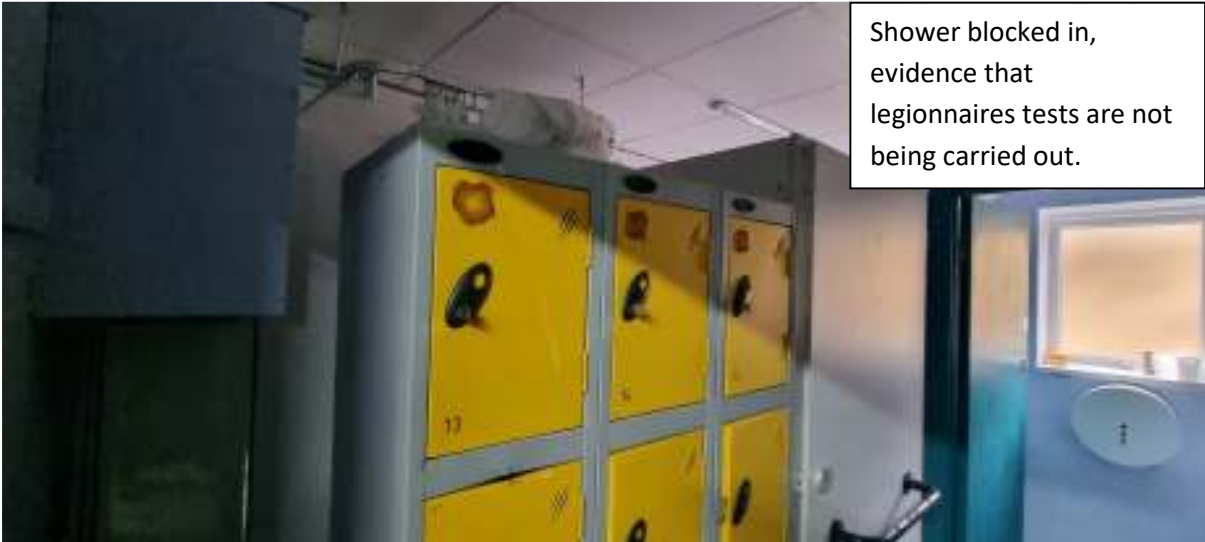
Shower blocked in, evidence that legionnaires tests are not being carried out.

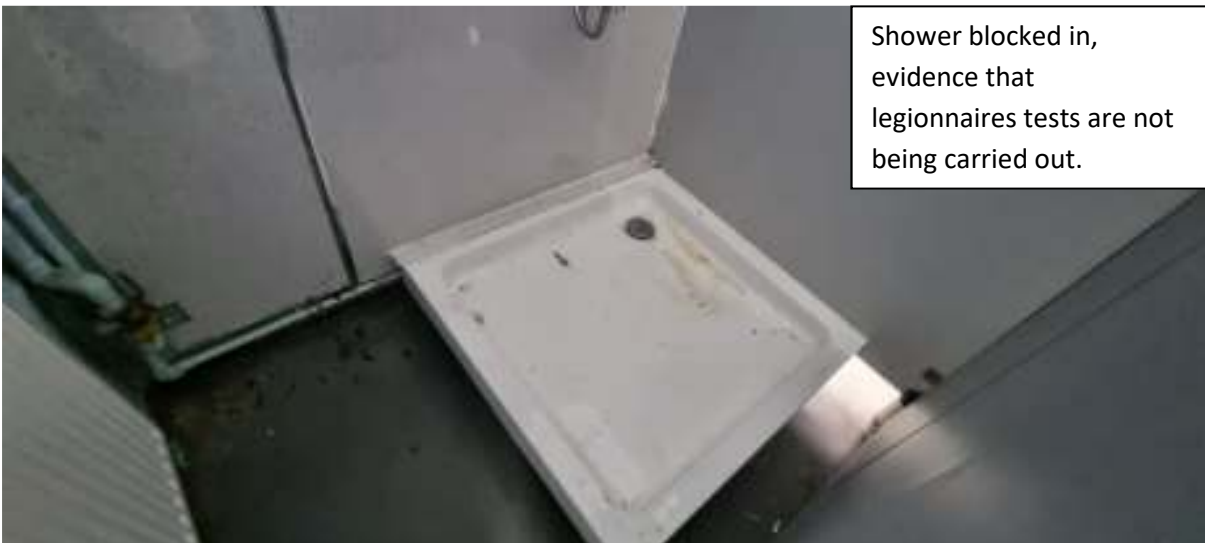
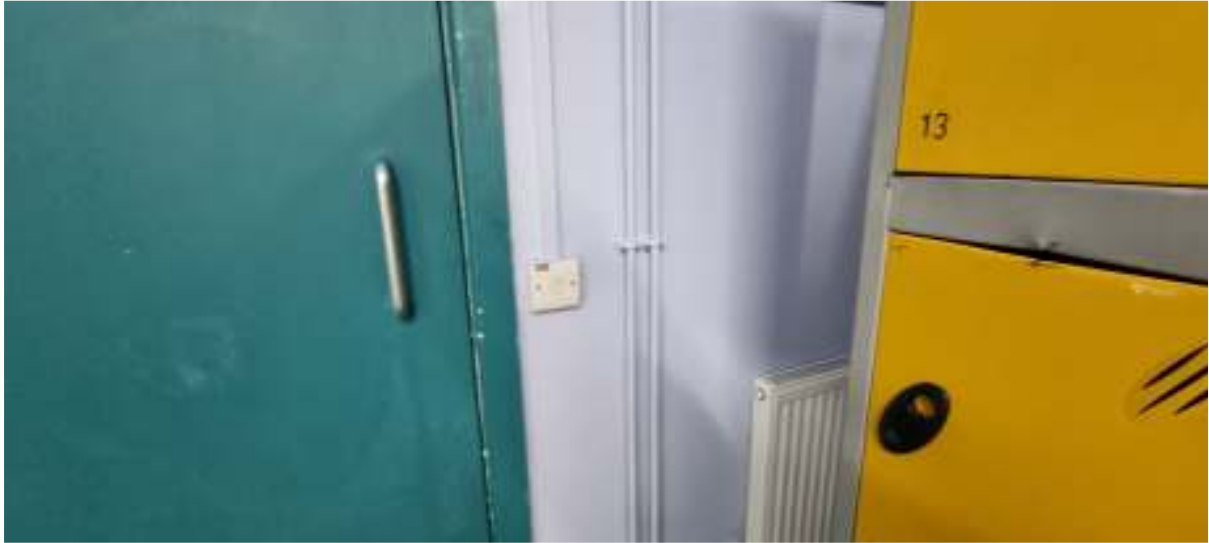
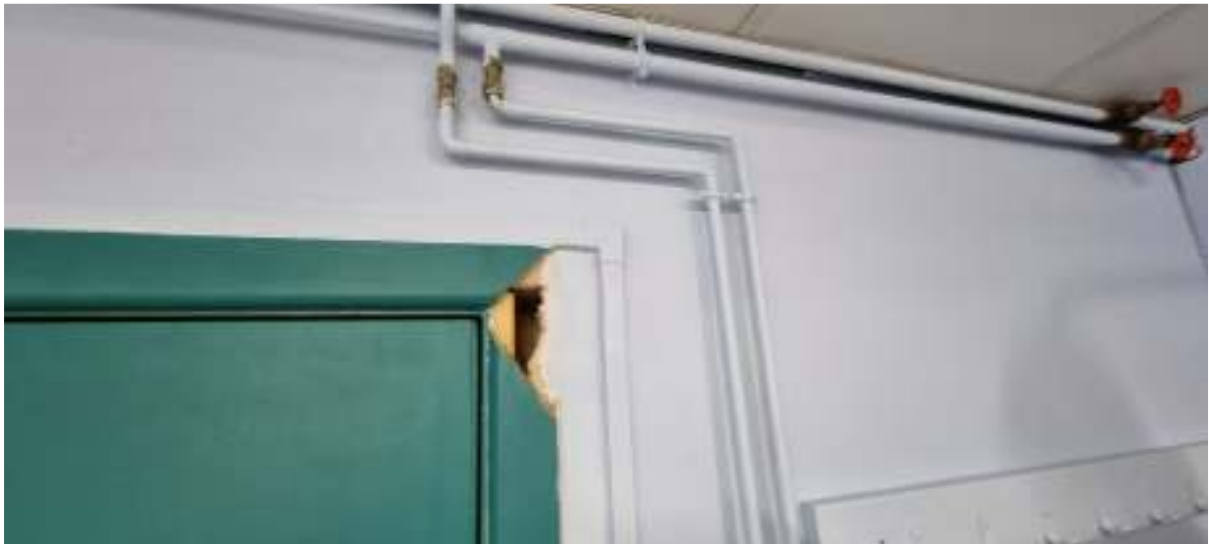
Switch not secured
potential for electric
shock.

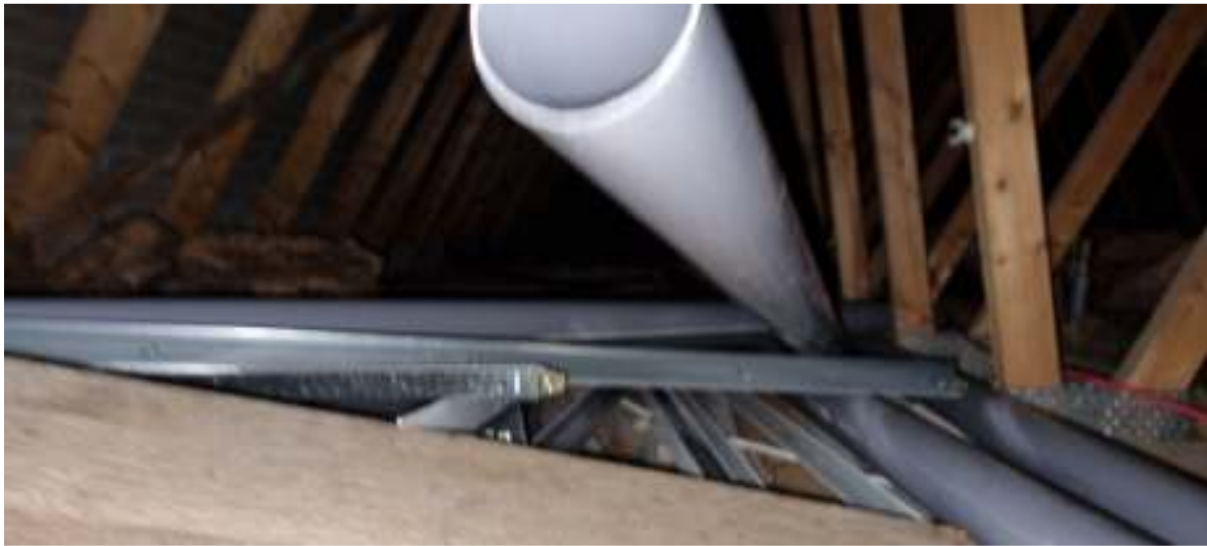
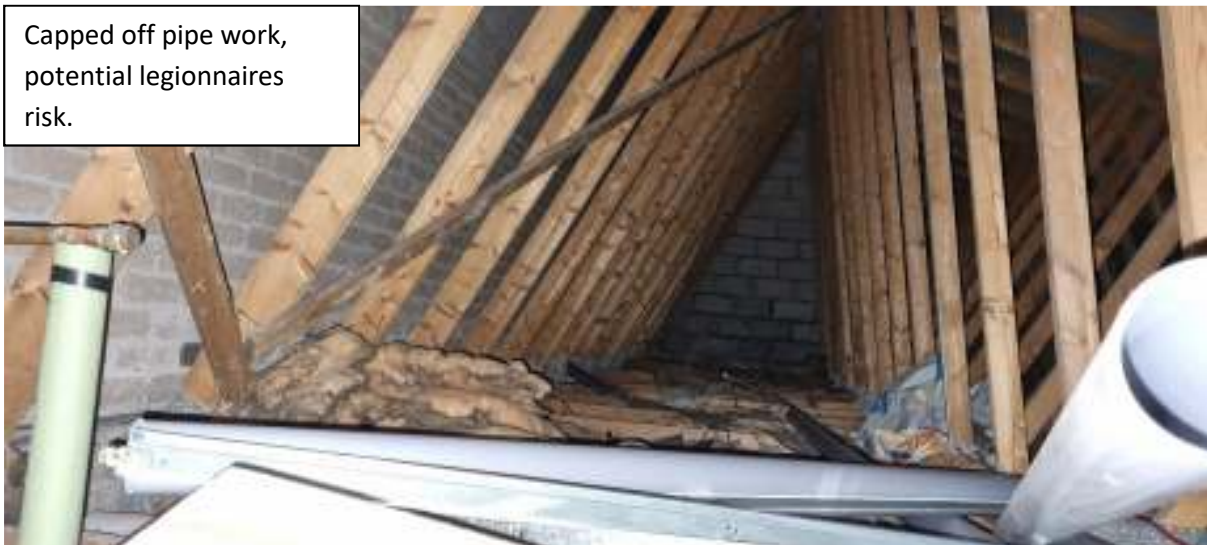
Capped off pipe work, potential legionnaires risk.

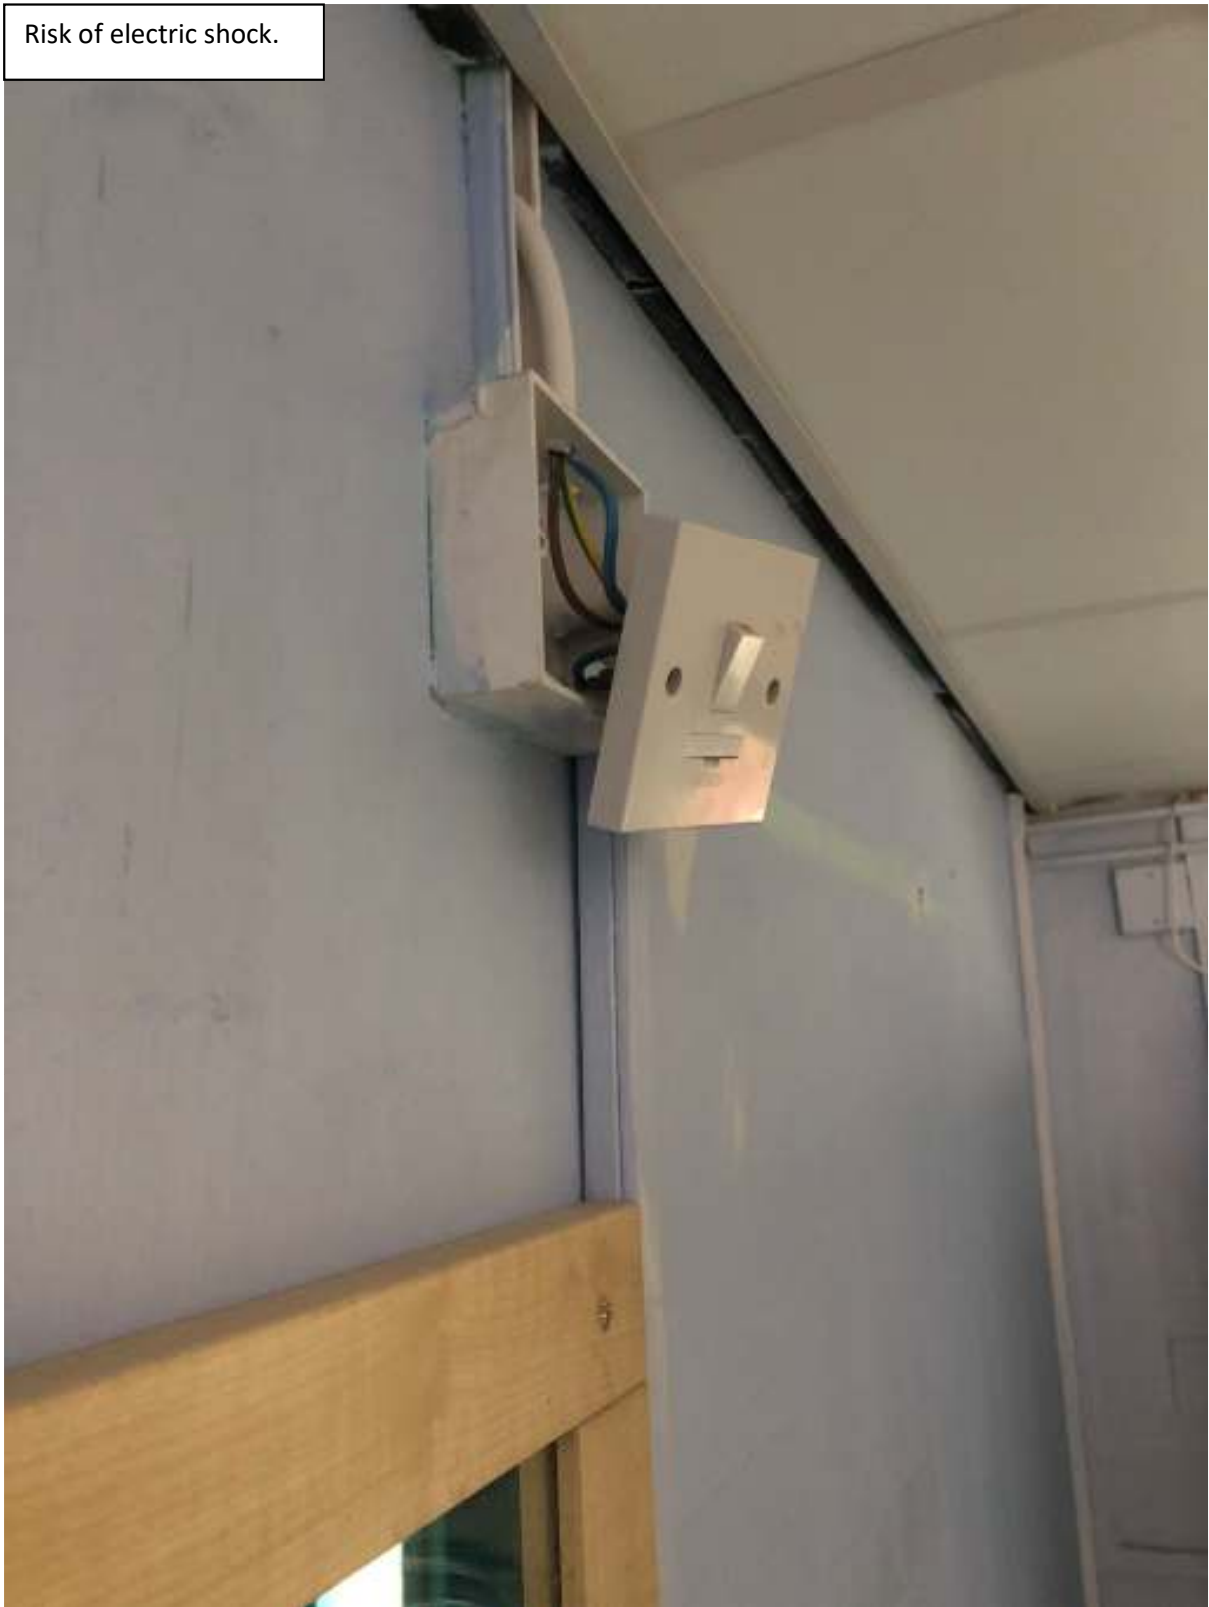
Risk of electric shock.

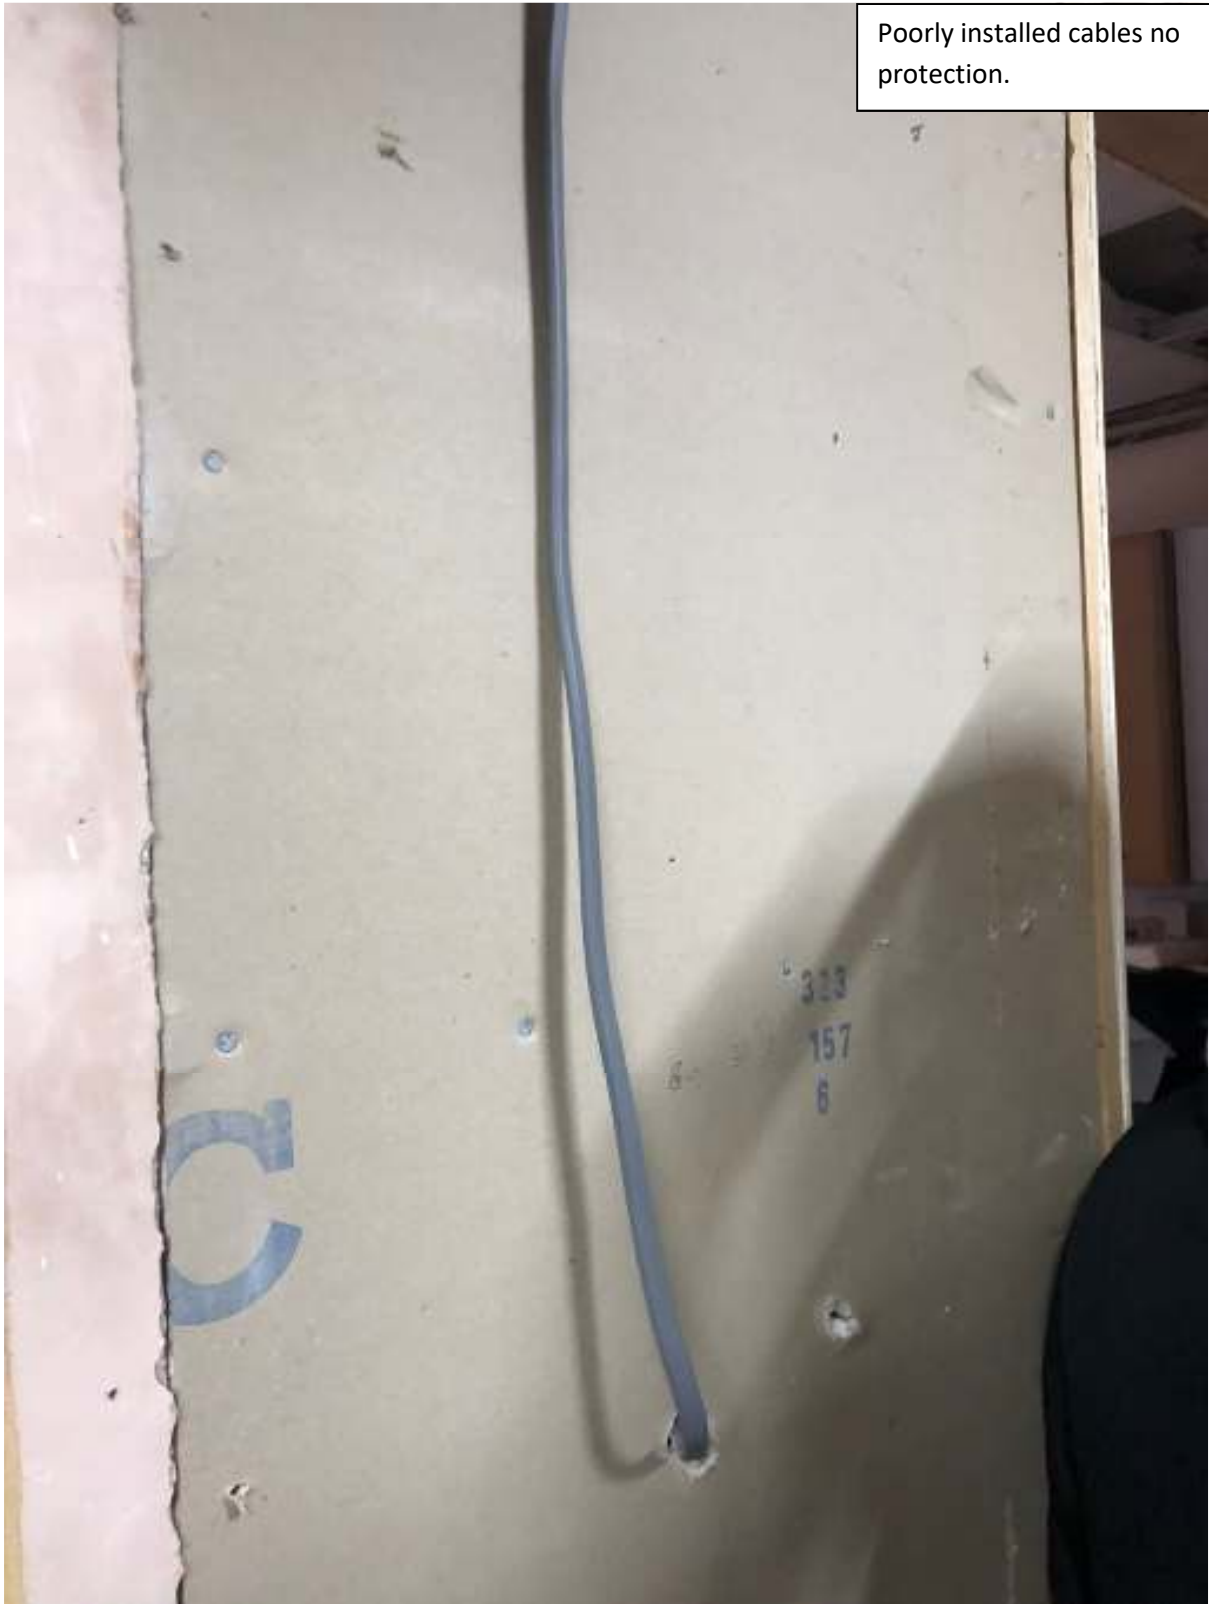
Poorly cut hole in the top of the water heater could lead to electric shock.

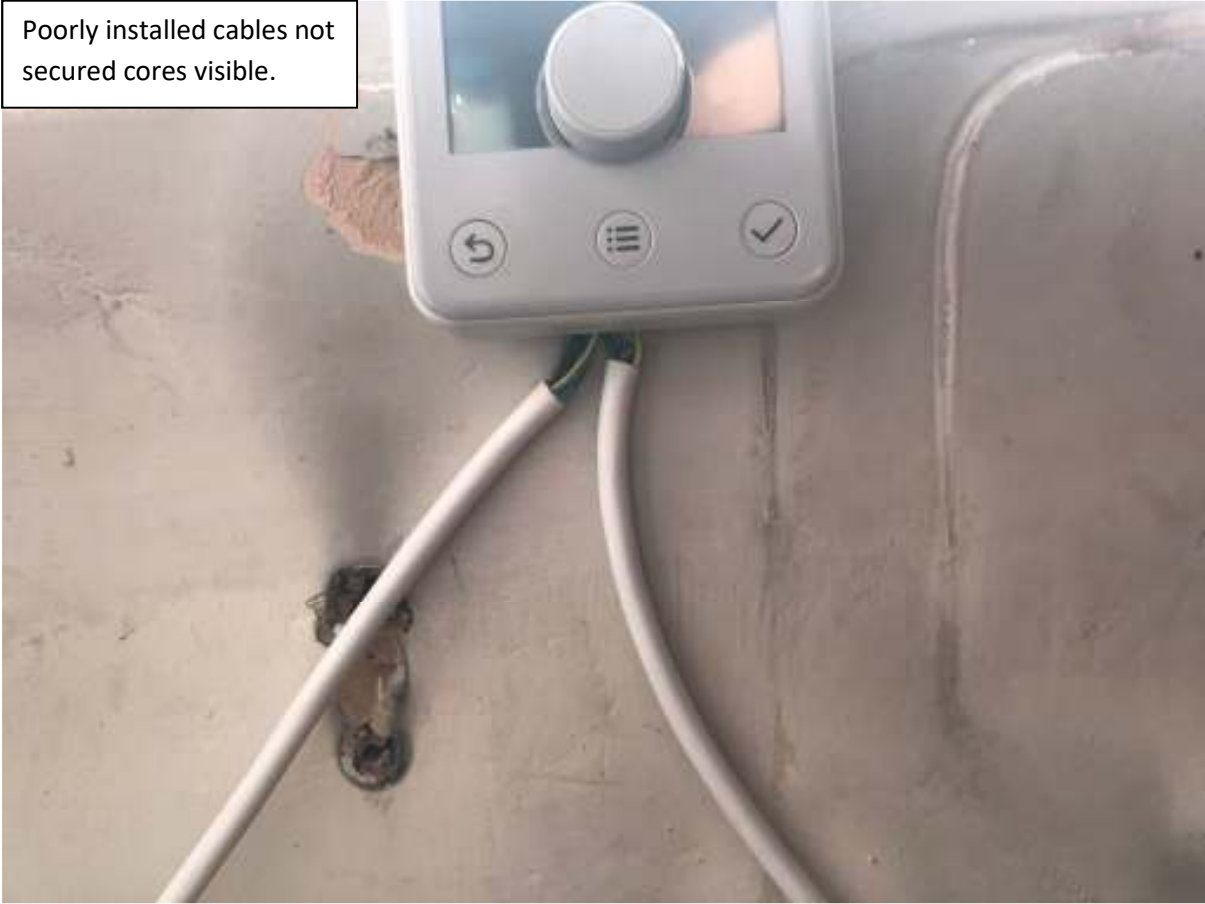
Poorly installed cables not secured cores visible.

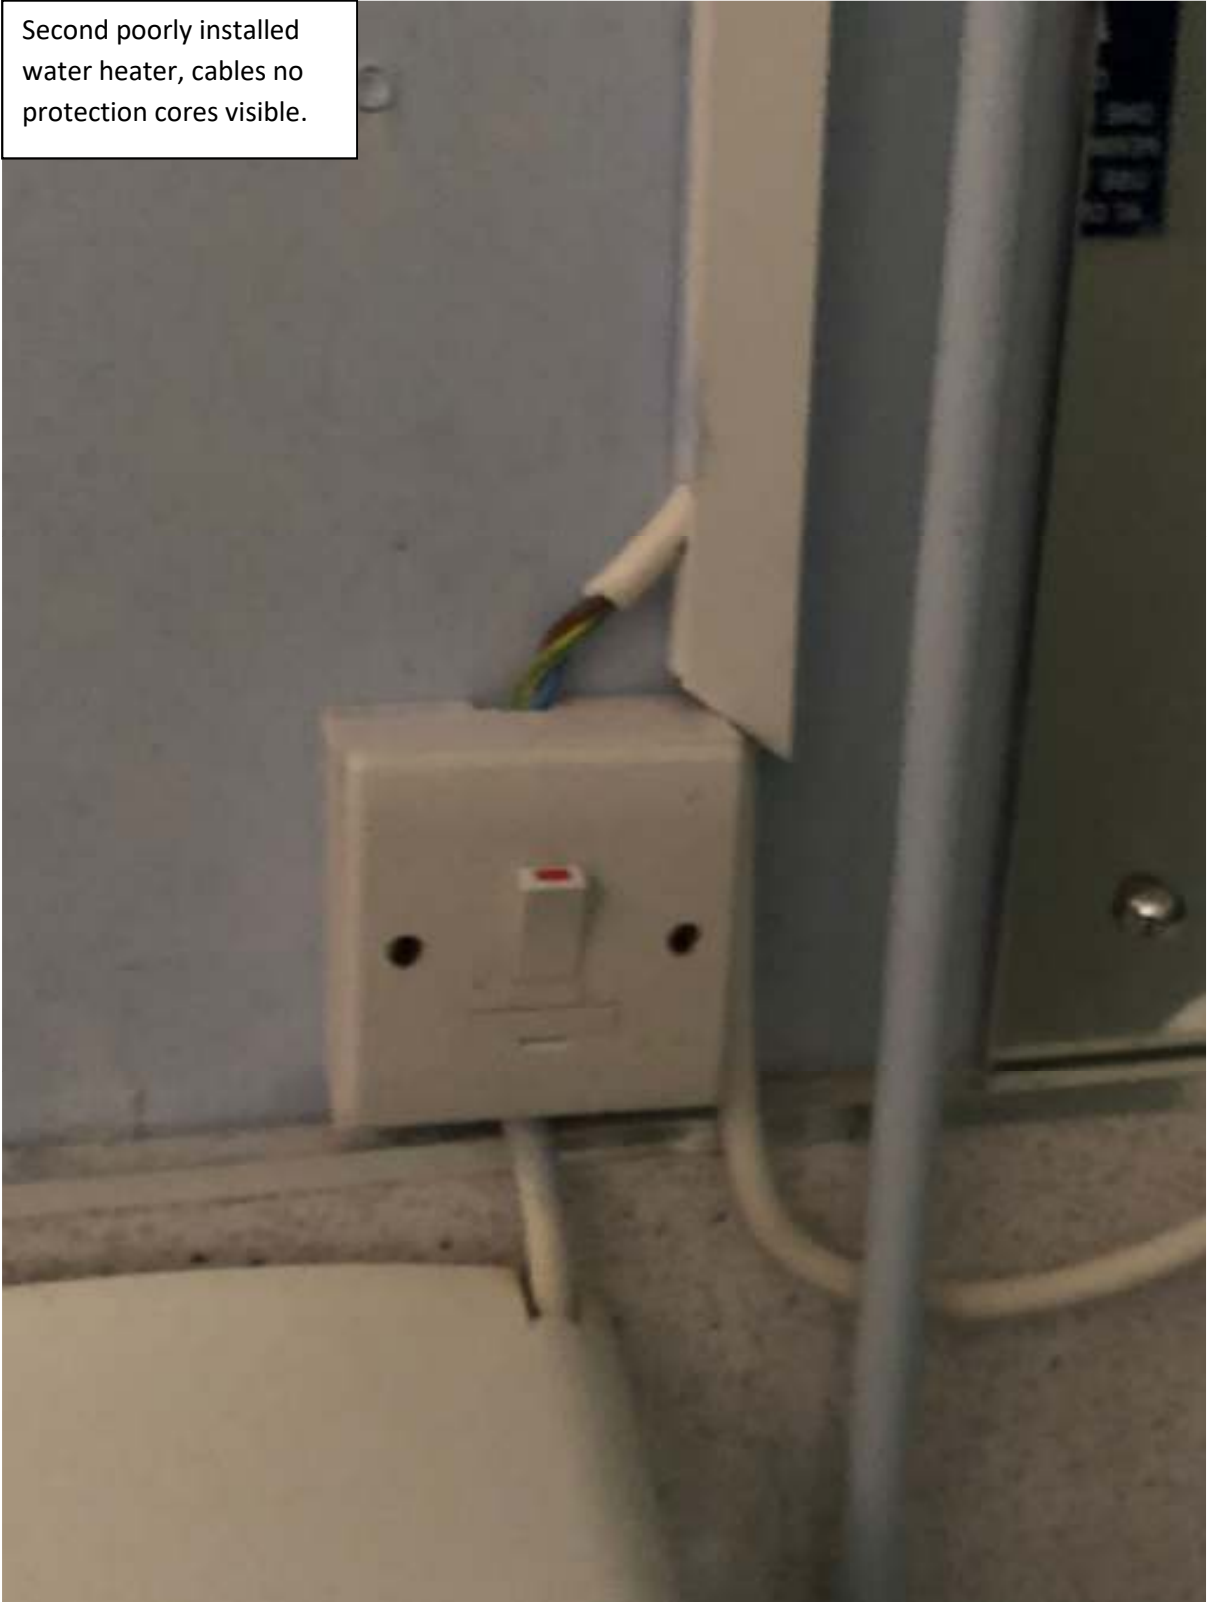
Second poorly installed
water heater, cables no
protection cores visible.
